**RE: Arborist Report for Potential Development Impacts for the Wolff Project near the intersection of Pacific and Midas Avenues in Rocklin, California.**

# **ARBORIST REPORT**

## **Wolff Project**

Arborist Report  
for  
Wolff Project  
Intersection of Pacific & Midas Avenues  
Rocklin, CA

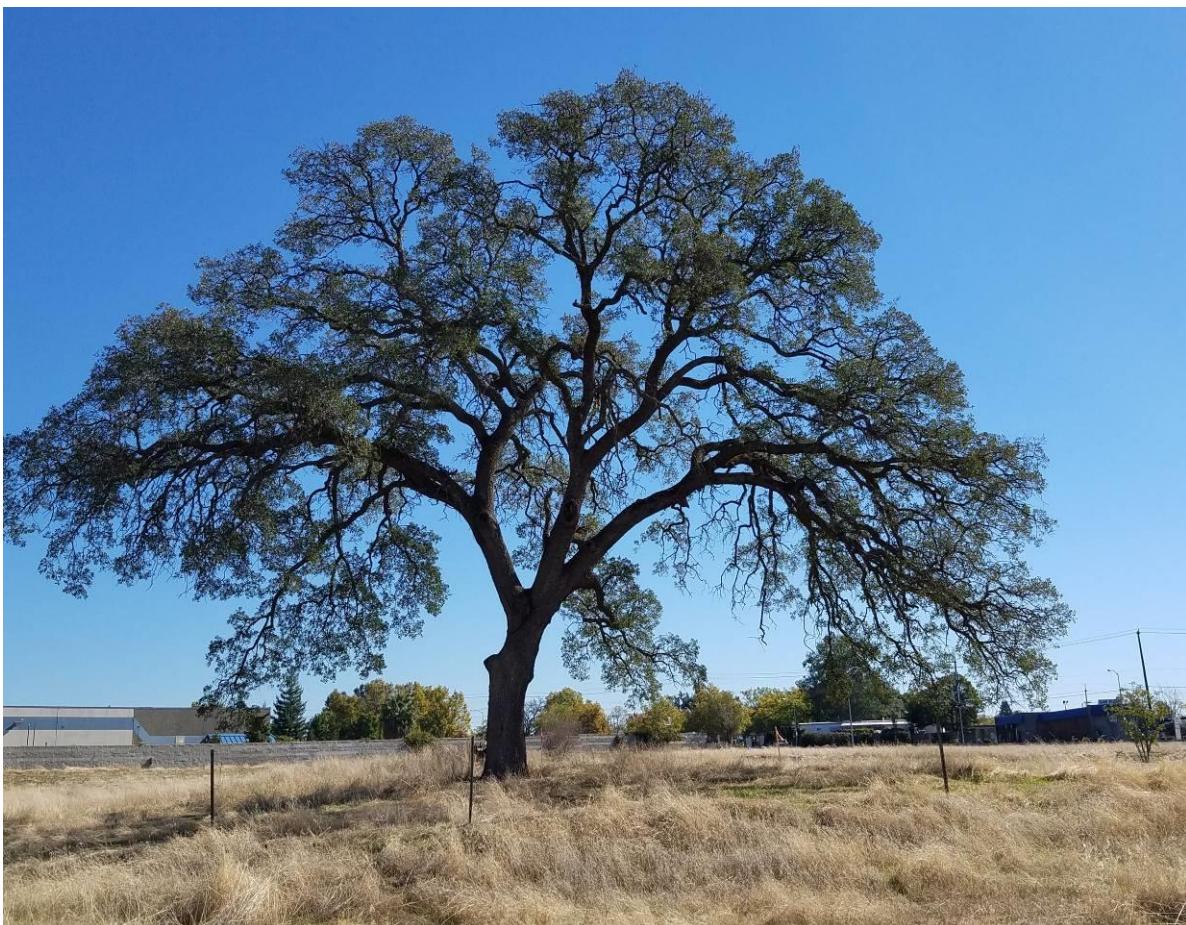
**Tree #65 -Example of a “Heritage Oak” on the property that upon investigation is in poor condition and not suitable for retention**

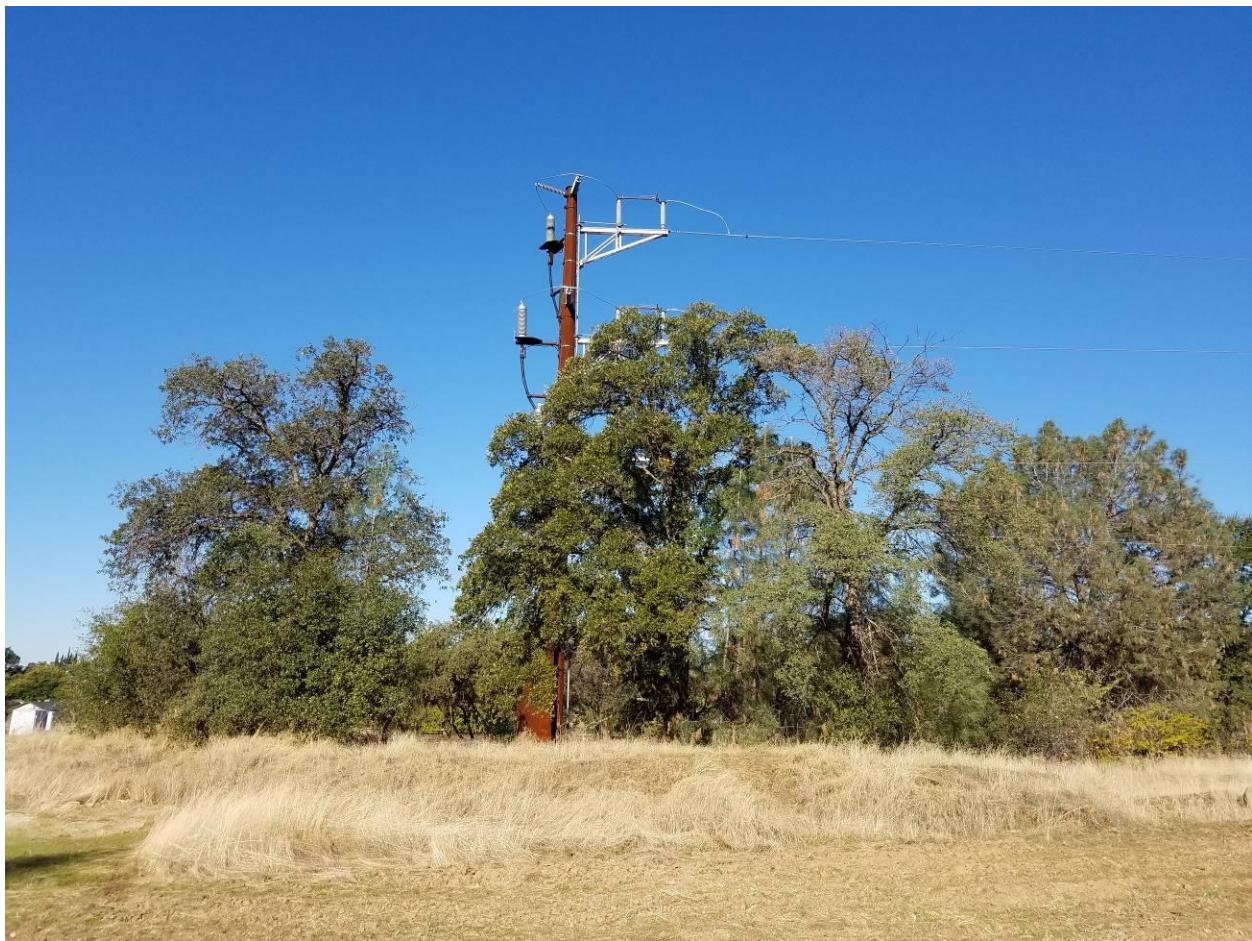
**Photo 1. Cluster of trees near high voltage wires**

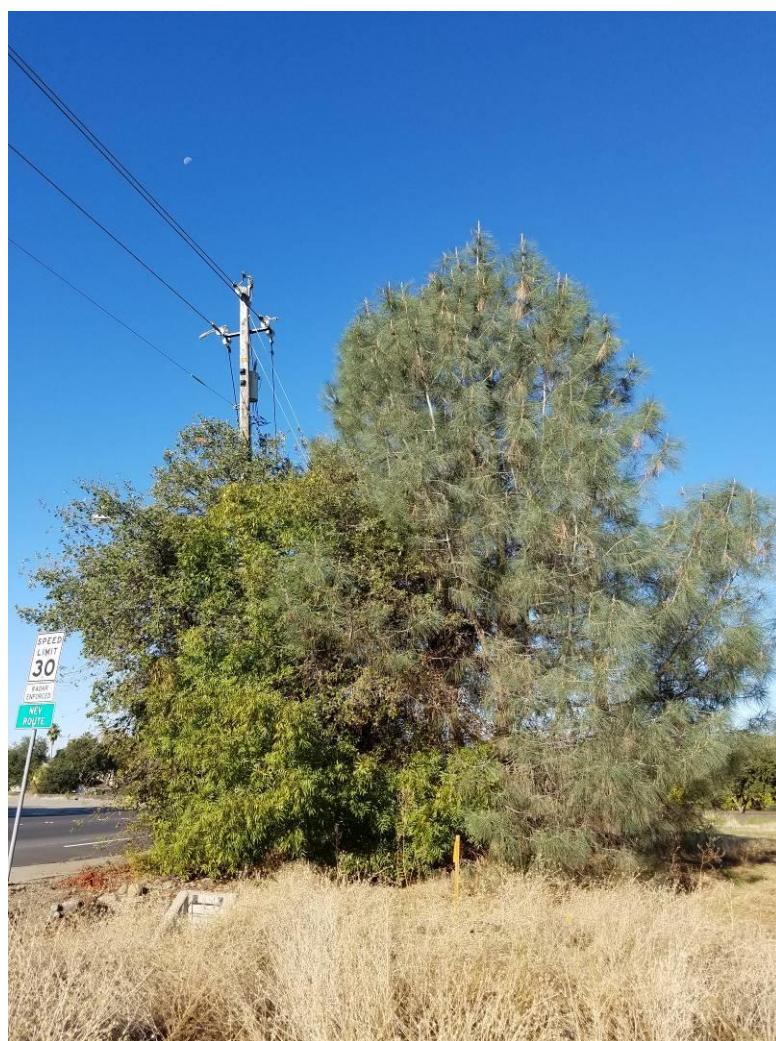
**Photo 2. Cluster of trees near Midas Ave.**

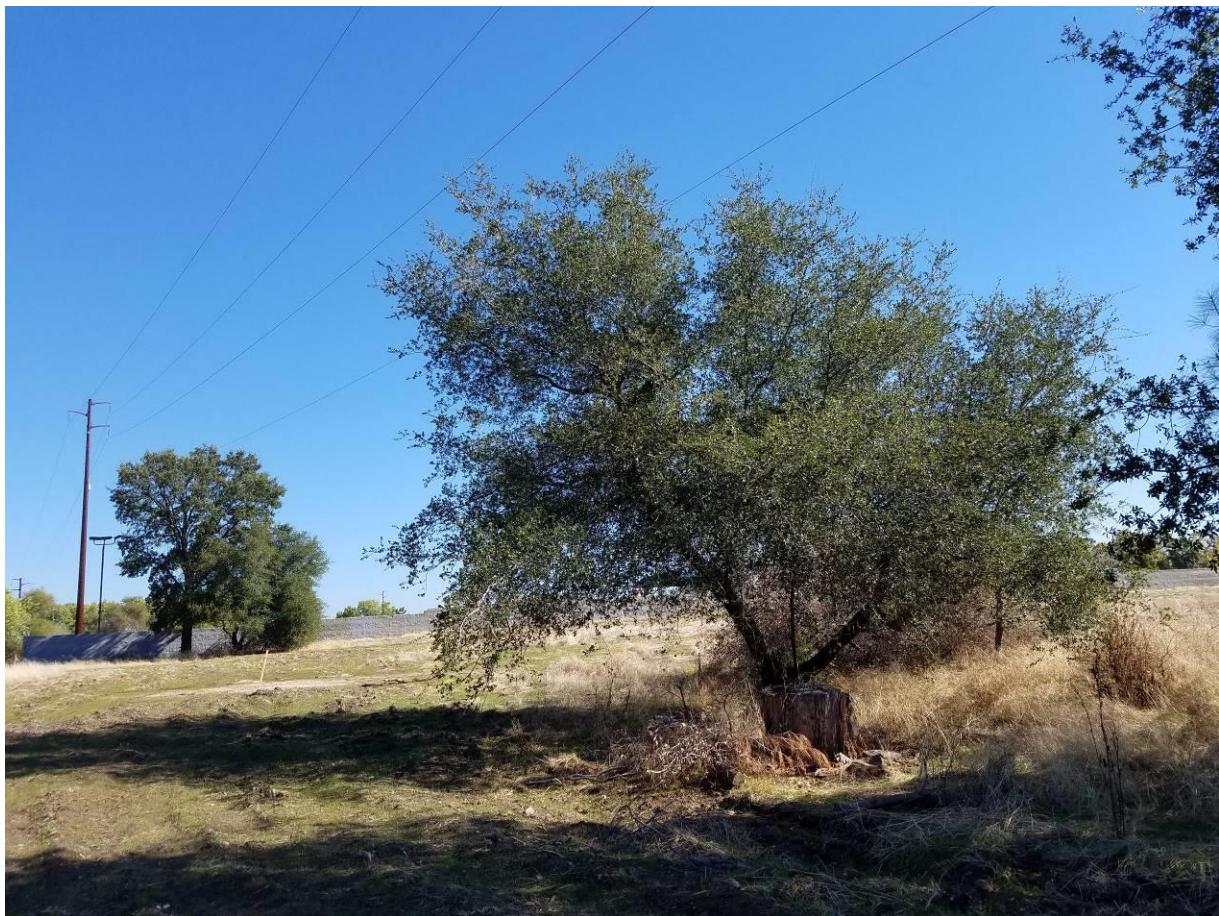
**Photo 3. Tree #62, Interior live oak with poor structure is a heritage tree**

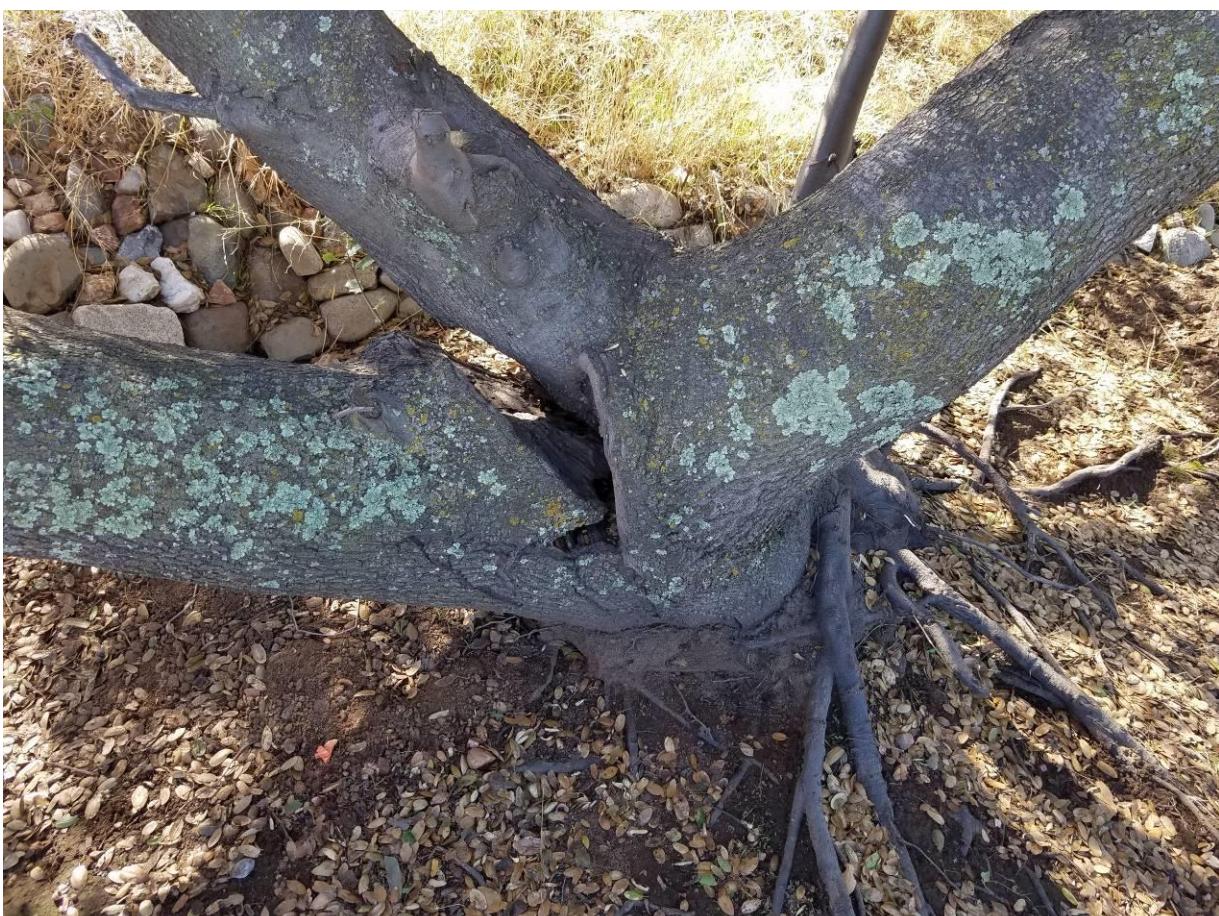
**Photo 4. Split stem of tree #62**
