Arborist Report & Oak Tree Assessment

4049 Granite Drive, Rocklin, CA

May 2018

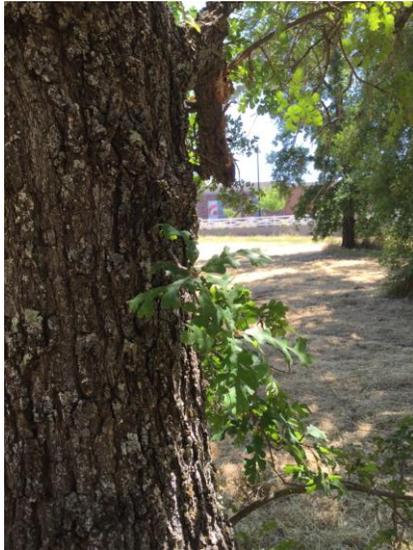
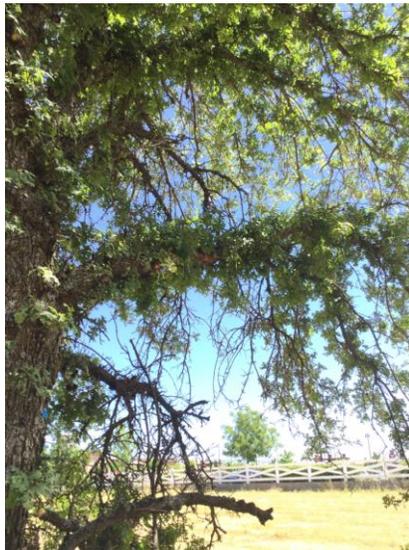
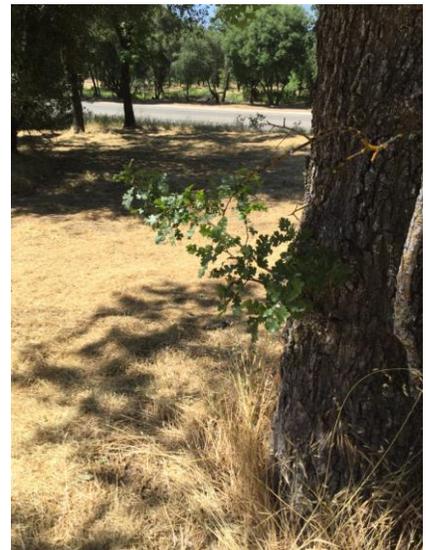
Epicormic Sprout Growth

Epicormic sprout growth is a manifestation of a tree's reaction to stress. The formation of these latent buds typically form immediately under the surface of the bark of the trunk or limbs. The emergence of these sprouts is the tree's attempt to produce stems with leaves which will enable the tree to use light energy to regenerate cells. If the primary growth on the tree is predominantly epicormic sprouts it is recommended that these trees be removed, as this is not considered to be adventitious growth.

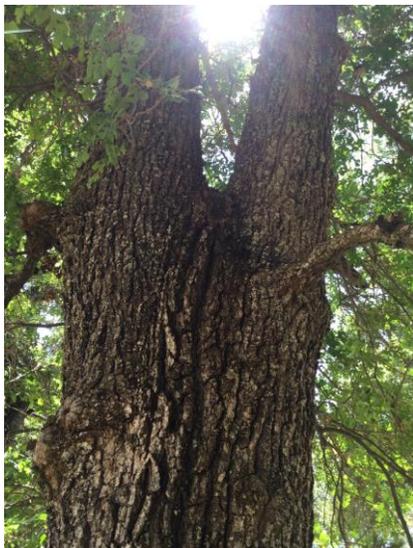
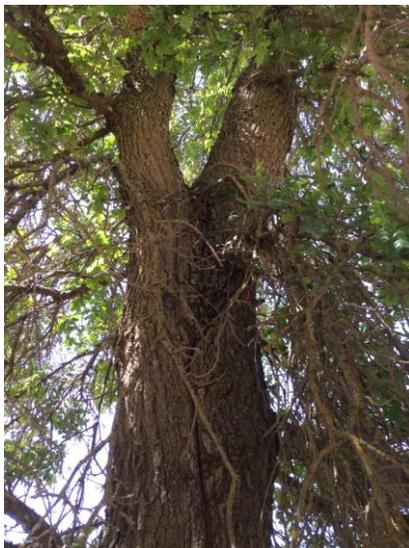
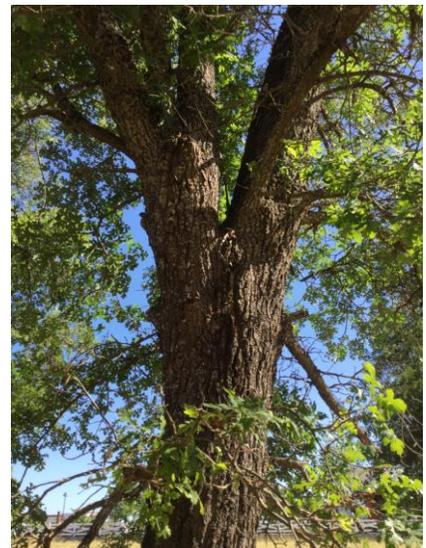
Included Bark

Included bark occurs when the joining leaders or trunks of the tree forming a "v" shape, which causes the tree to overproduce bark at the union. This leads to weak attachment and can ultimately cause splitting and failure because the bark produced cannot hold the weight of the limb or leader. If trees are within the tree protection zone, they should be structurally pruned to balance canopy and completely remove co-dominants if doing so does not have a detriment on the overall structure of the tree.

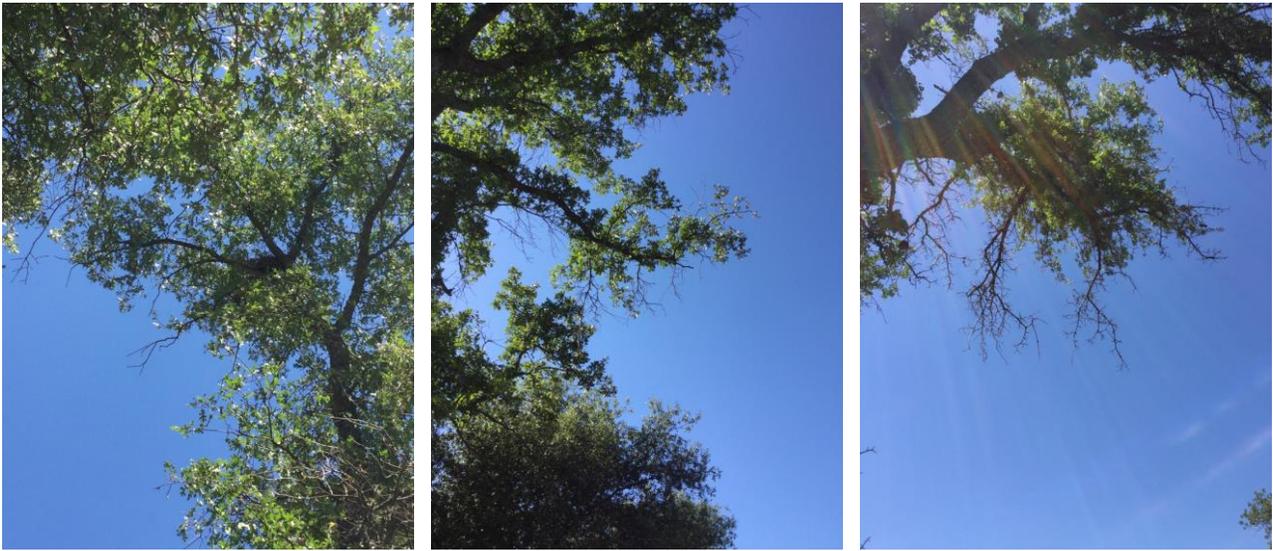
Crown Dieback

Crown dieback is a symptom of stress on a tree, in which the tree quickly loses leaves or is unable to produce leaves at the tips of the branches. This ailment typically begins in the uppermost portion of the canopy and works in towards the trunk of the tree. In our climate drought stress leading to decreased moisture & oxygen in the root system inhibit the trees ability to transfer water & nutrients throughout the crown. If trees are within a protection zone, they should be pruned to reduce risk of limb failure.

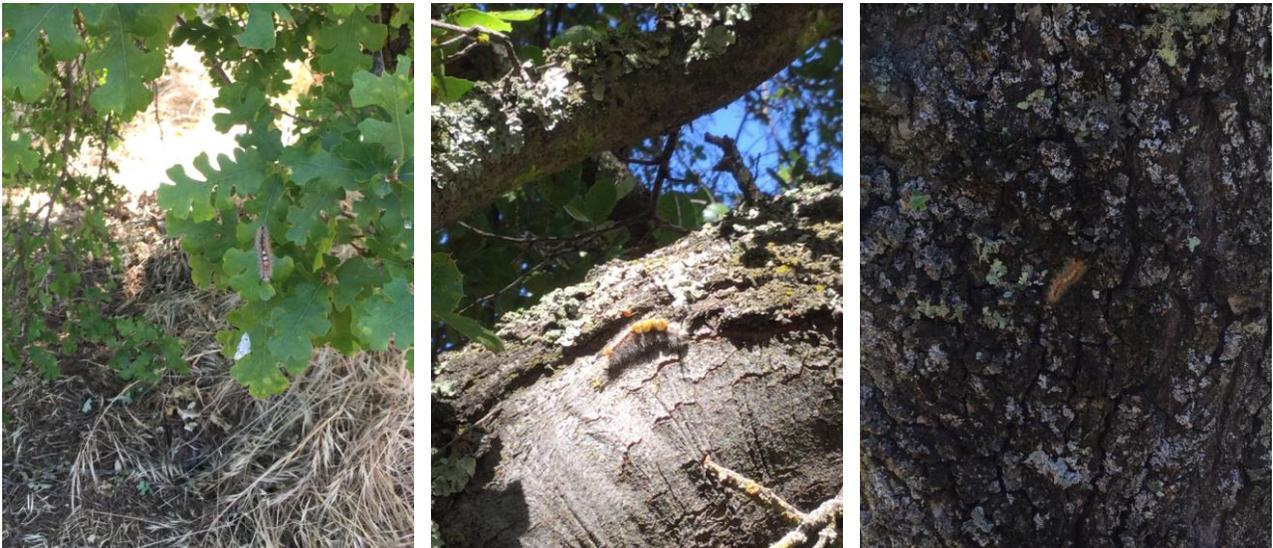
Tussock Moth Infestation

Western Tussock Moths are a pest which feed on the foliage of a variety of trees within our climate. These are a seasonal pest and can be managed using insecticidal treatment for large areas. Although it is unlikely that these pests will kill a tree, the risk associated is attributed to the fact that some people have a severe allergic reaction to the hairs that the caterpillars shed and those which are found on their eggs. If trees are within a protection zone they should be treated prior to occupancy of the space.

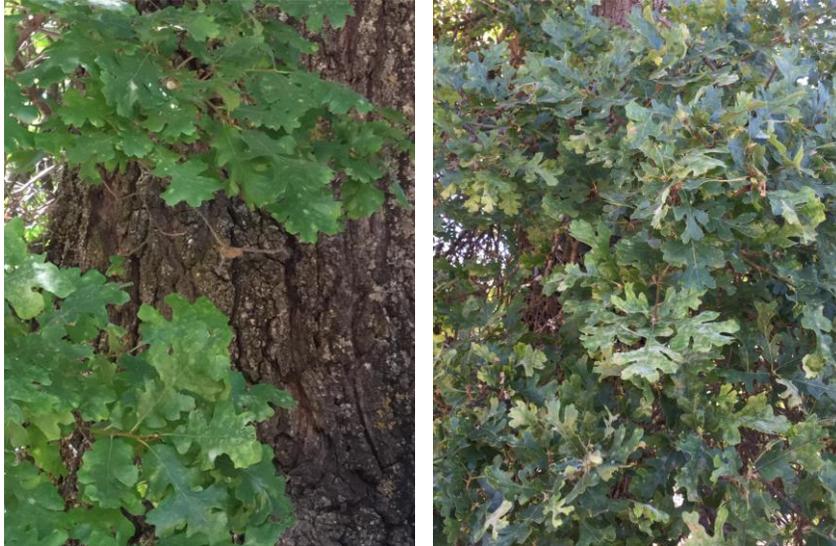
Powdery Mildew

Powdery mildew is a fungus that grows on the surface of valley oak trees, typically on young spring growth because the moisture level of these leaves is higher. This fungus can cause premature leaf drop, but is not lethal to oaks in most cases. At this site, no action is necessary because the affected trees on this site are currently in moderate health and have supplemental growth to support the tree. If trees are within the tree protection zone, they should be treated upon project completion if fungus is still present.
