California Tree and Landscape Consulting, Inc.

February 12, 2021

PRE-CONSTRUCTION ARBORIST REPORT & TREE PRESERVATION PLAN

RE: **4080 Delmar Avenue, APN 045-011-013, City of Rocklin Jurisdiction**

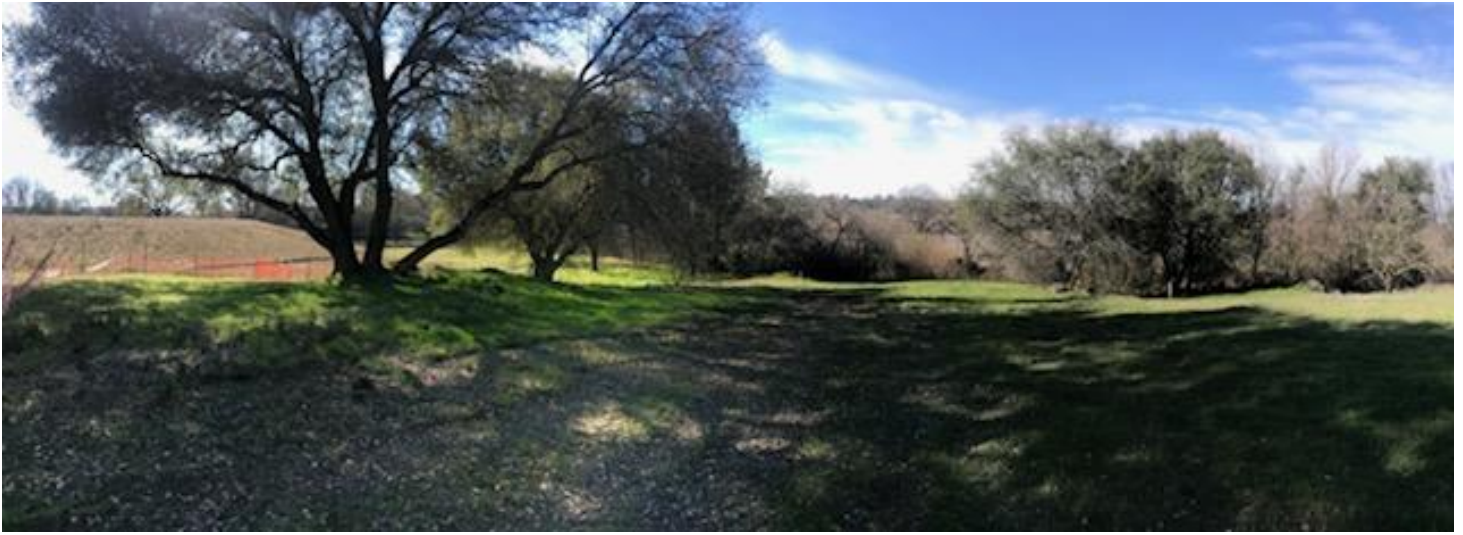
Photo #1, Offsite Trees 86, 87, 90, 88 on the left

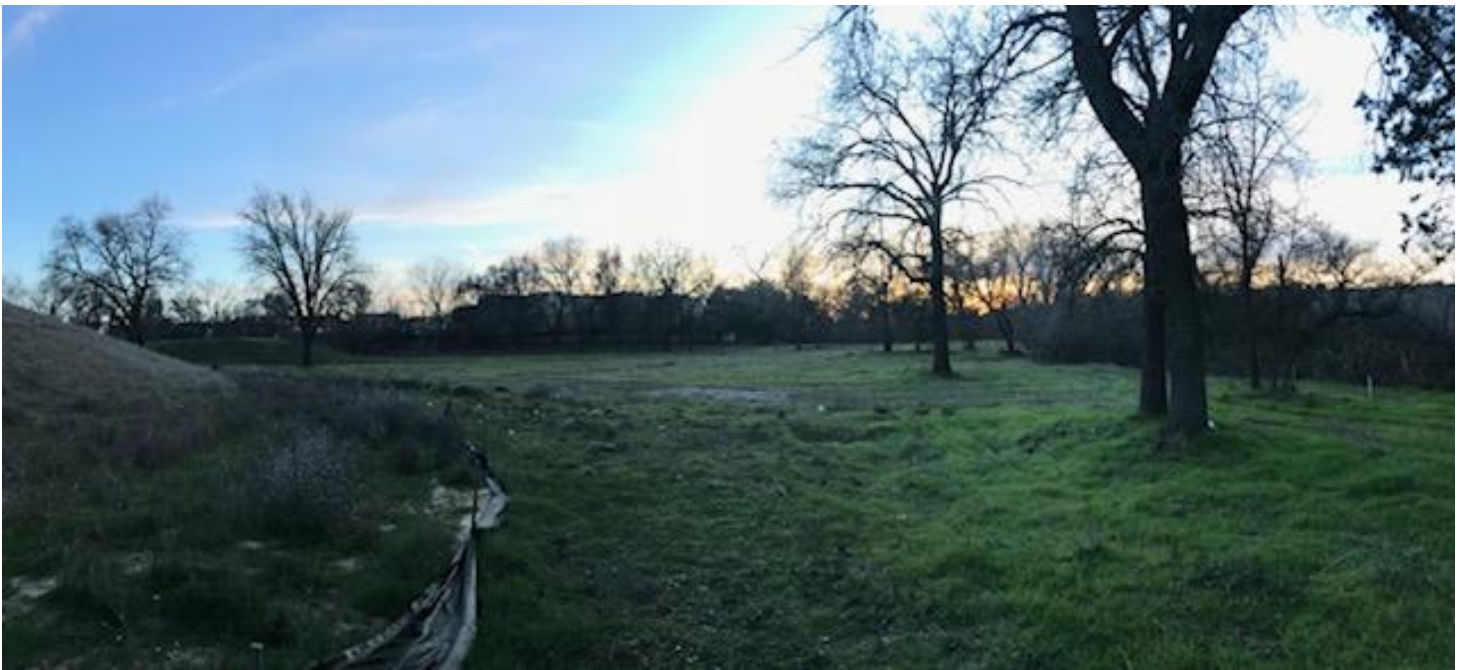
Photo #2, Looking roughly south southwest. Trees 50 and 51 on the left and 390 and 391 on the right.
