3.5. Privately-maintained trees along residential streets

3.5-Privately-Maintained Trees along Residential Streets

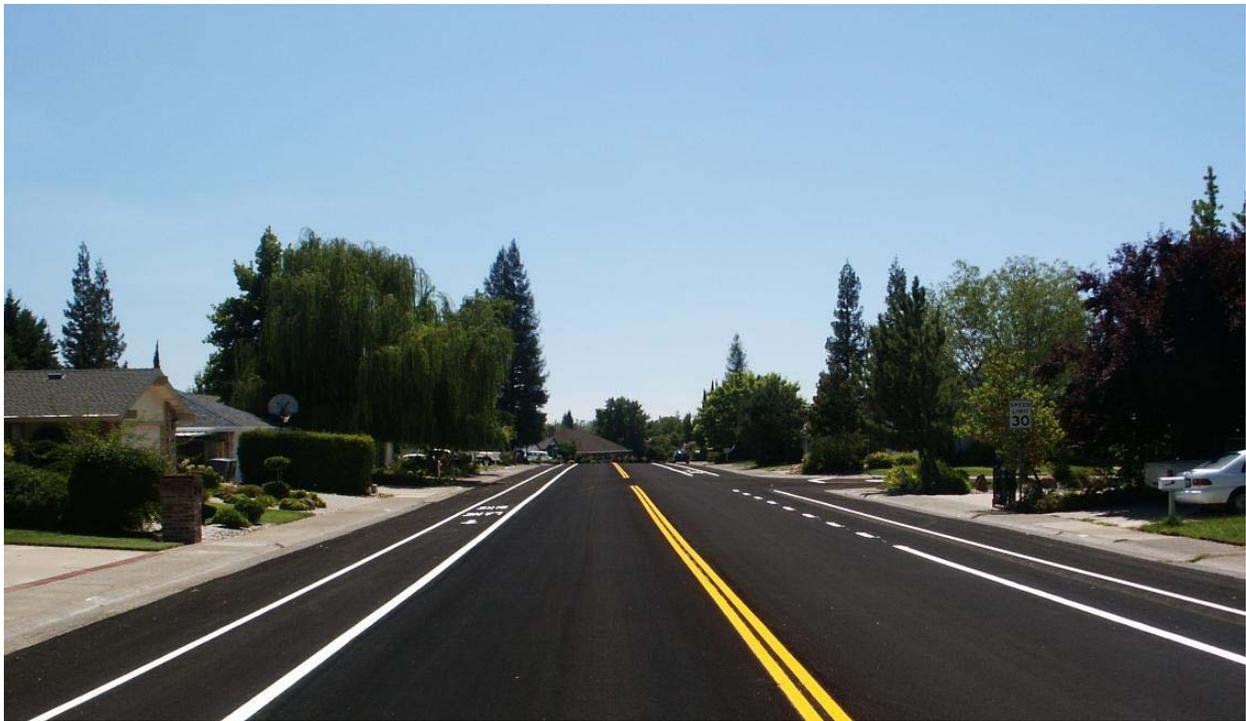
Figure 3.5-2. Older subdivision with a wide street along Argonaut Avenue. Current street canopy cover was rated at less than 1%.

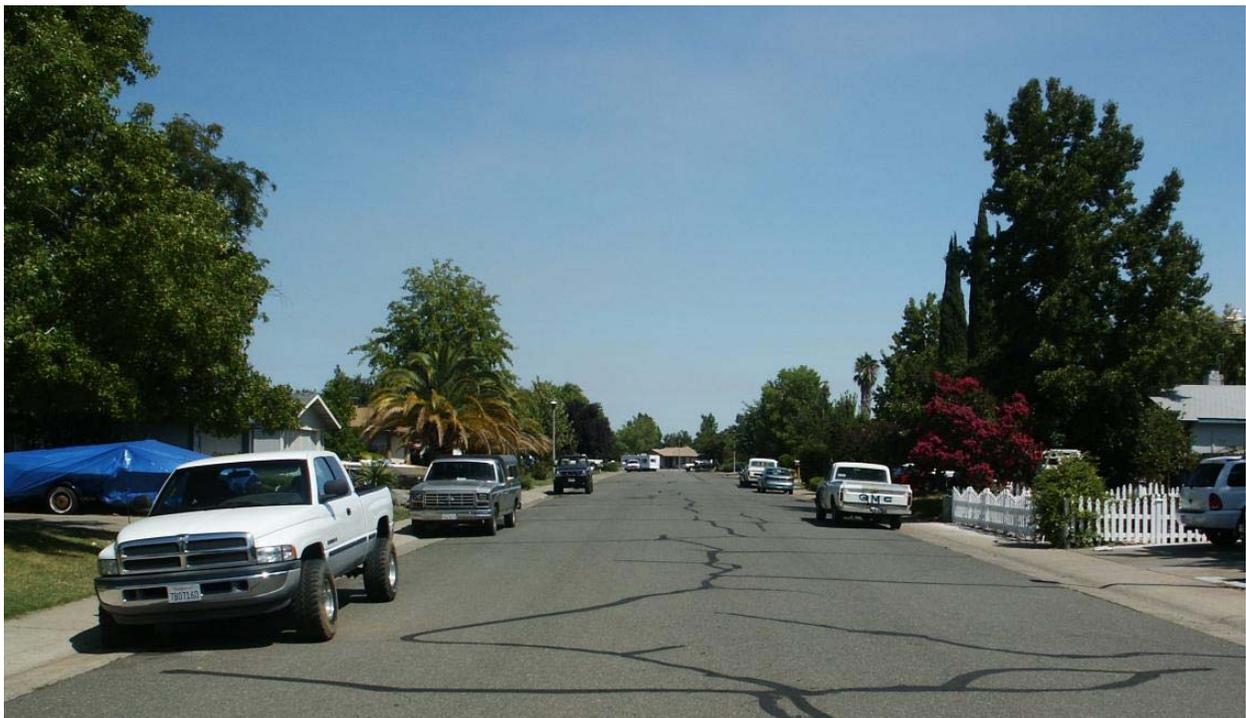
Figure 3.5-3. Older subdivision with a standard street width along Racetrack Circle. Street canopy cover was 0% within the surveyed segment.

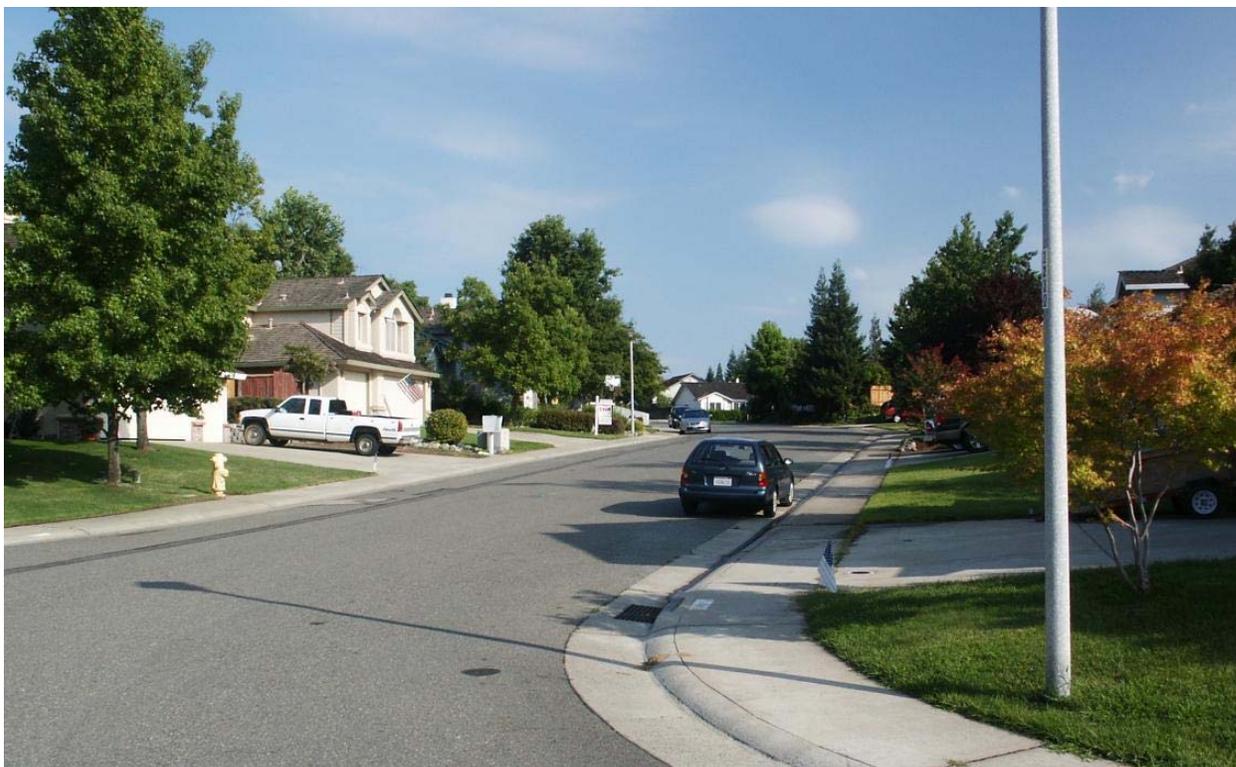
Figure 3.5-4. Older subdivision along Outlook Drive. Current street canopy cover was rated at less than 1%.

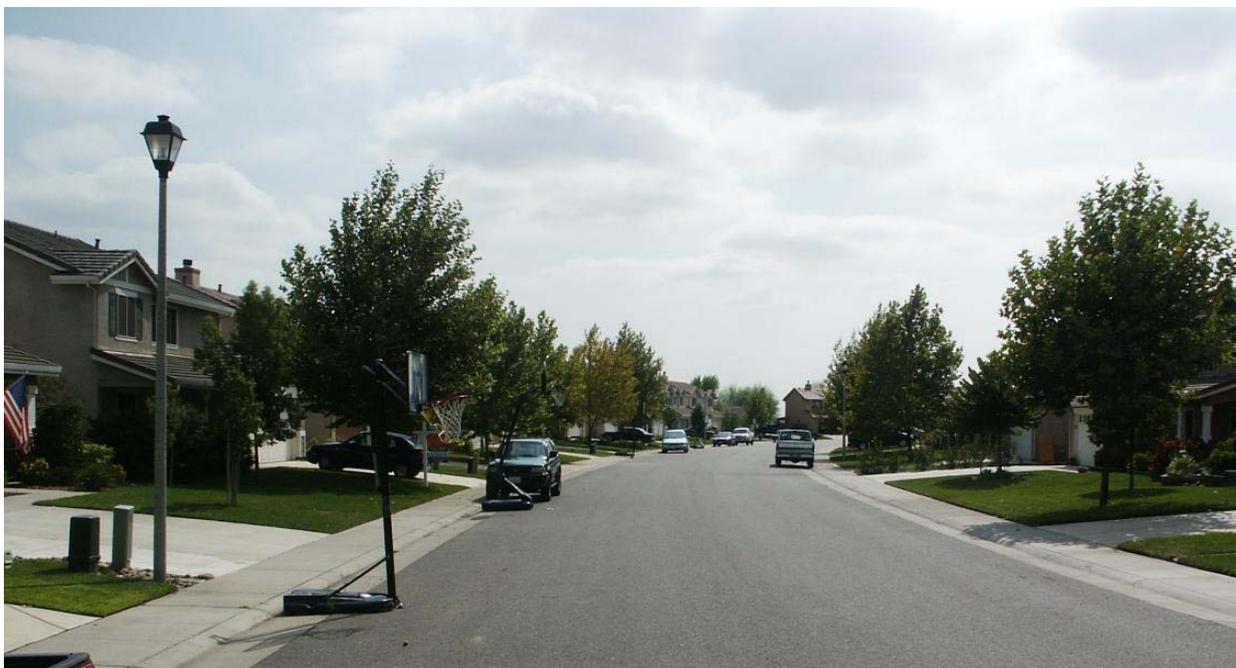
Figure 3.5-5. Recent subdivision along Jersey Drive. Current street canopy cover was rated at less than 1%. London plane trees are planted relatively close to the street. If these trees are allowed to reach mature size, street tree canopy cover should increase substantially.

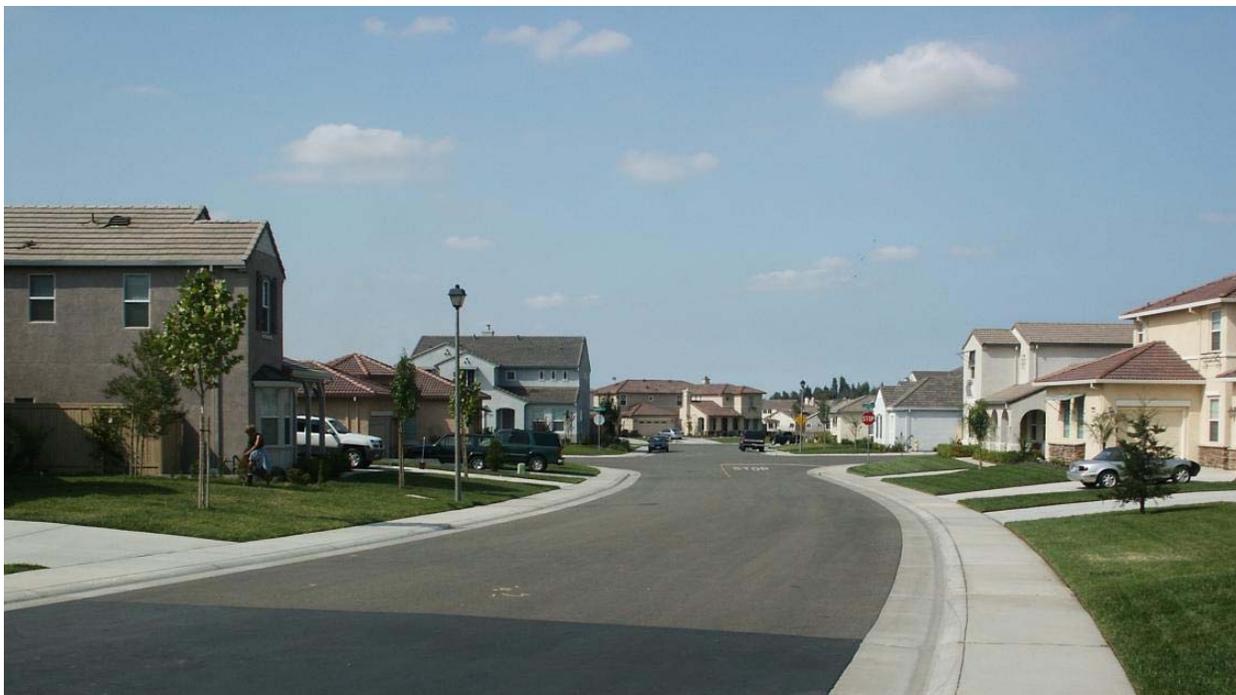
Figure 3.5-6. Recent subdivision along Puffin Court and Swan Court. Current street canopy cover was 0%.

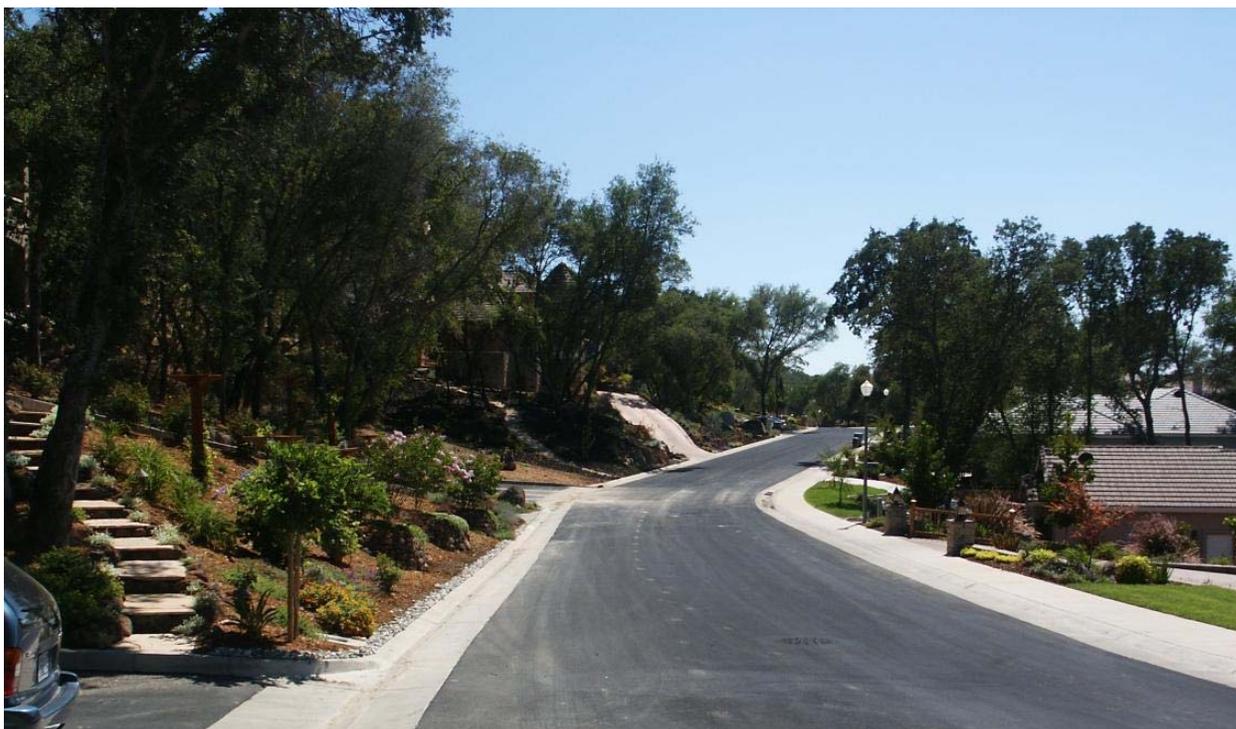
Figure 3.5-7. Recent subdivision along Clubhouse Drive with narrow streets and numerous conserved oak trees. Current street canopy cover was rated at between 1% and 5%.

The two streets with large lots (Clubhouse Dr. and Dry Gulch Ct.) had much higher tree densities of 746 and 890 trees per street mile. These high counts were associated with lower housing densities, high numbers of conserved native trees, and especially deep front yards (Figure 3.5-7). Because of these differences, direct comparisons between these numbers and those in more typical subdivisions are not meaningful.

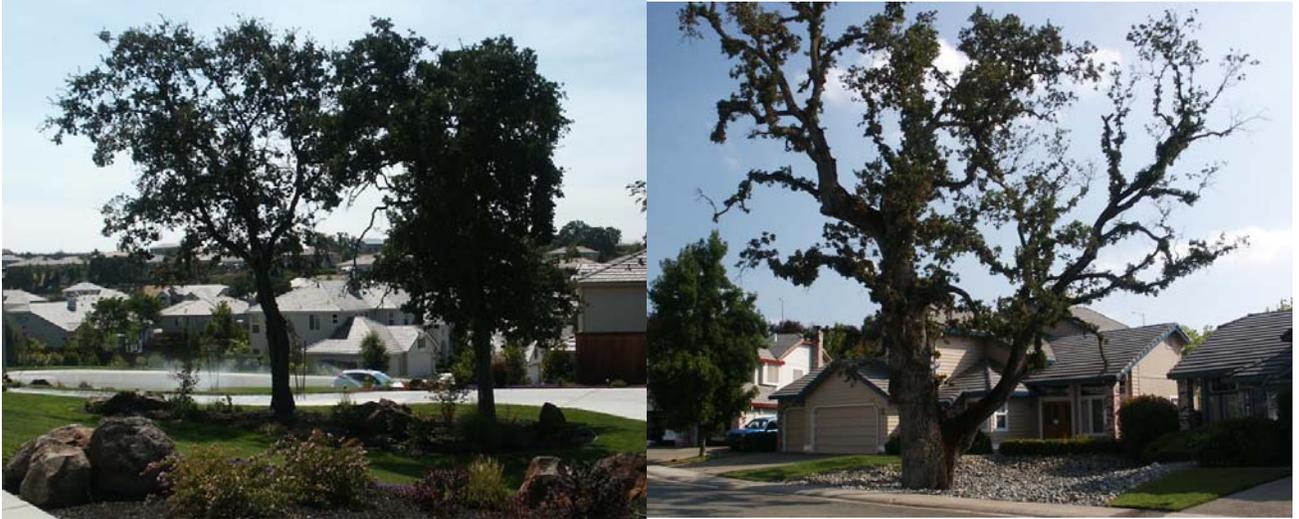
decline. Figure 3.5-10 shows typical situations in which declining trees are found. Most of these trees were severely damaged during the time that the homes were built because their roots were inadequately protected from damage associated with grading and other construction activities. In many cases, improper irrigation practices following construction have further accelerated tree decline.

Figure 3.5-10. Nearly half of the native oaks that have been retained during development are in decline due to adverse impacts to their root systems. At left, one of the two blue oaks retained in this recently-built subdivision shows early evidence of canopy thinning due to root damage. Irrigation runoff from turf is likely to speed decline. At right, retained valley oak in older subdivision shows extensive canopy thinning and is in severe decline.

Many conserved oaks have not fared well in residential front yards. Trees in these areas are typically subject to high amounts of root disturbance associated with grading and compaction for house pads, driveways, streets, and trenching for underground utility lines. In some situations, the City's current guidelines related to oak tree protection have clearly not been followed. Even if followed precisely, the City's current guidelines may not be sufficient to protect enough of the rootzone to maintain tree health. For example, the oak ordinance requires actions to protect roots only under the tree's dripline. Because roots of mature oaks typically extend out twice to three times the diameter of the canopy, the area under the dripline may include as little as one quarter to one third of the tree's roots. Destruction of close to half of a mature oak's roots can greatly stress the tree and may cause it to decline. The City may want to consider revising the guidelines to encourage greater levels of rootzone protection where it is feasible.

In addition, landscape design and maintenance practices instituted after construction is complete often do not conform to the City's guidelines or current best management practices. Further efforts may be needed to enforce compliance with oak protection measures during development, and encourage better stewardship of retained oaks by homeowners. Efforts to increase the planting of locally native oaks where appropriate could also be used to help maintain native oaks as an element of Rocklin neighborhoods.
