3.6. Trees in commercial parking lots

3.6-Trees in Commercial Parking Lots

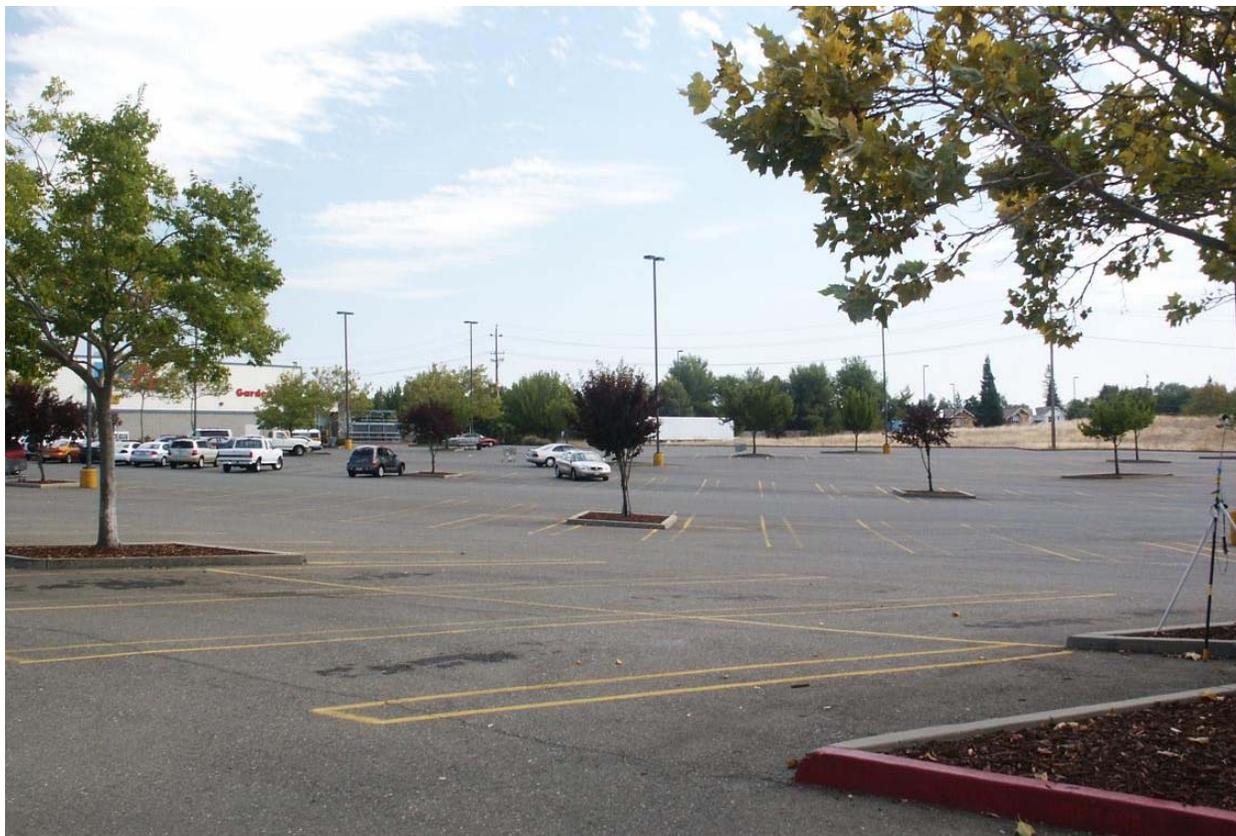
Figure 3.6-1. Parking lot 6 has relatively large planters, but trees are widely spaced with only one tree per nearly 8 parking spaces. About 12% of the surveyed parking spaces were at least 25% shaded.

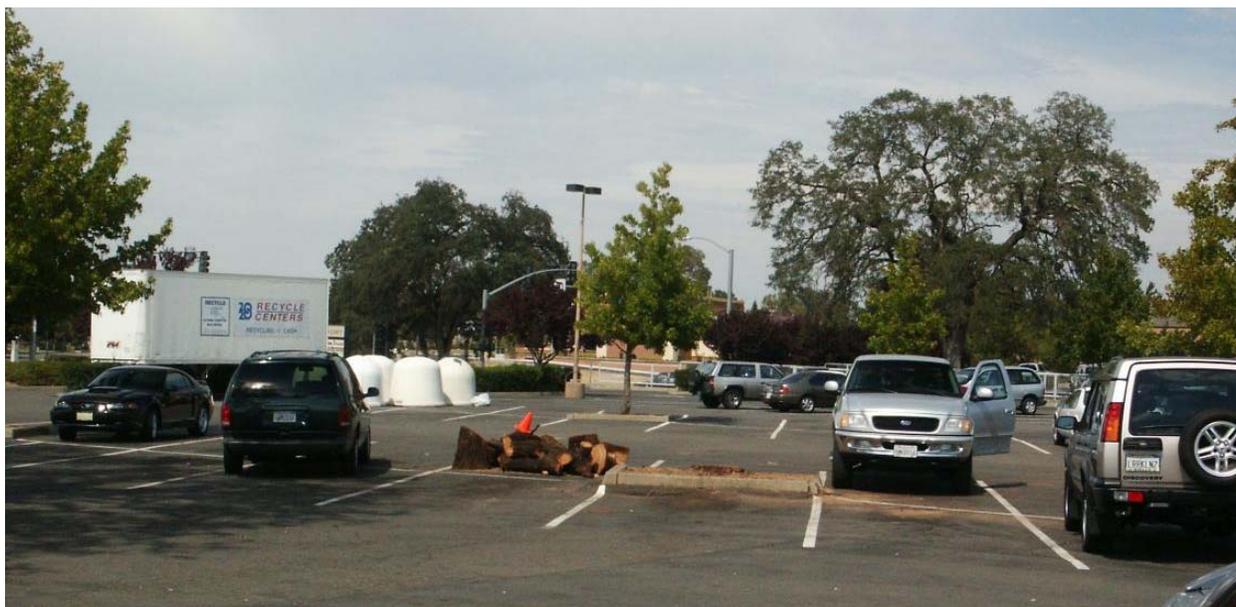
Figure 3.6-2. Large eucalyptus trees at lot 5 were being removed at the time of the survey, reducing tree canopy. This lot included several conserved oaks, including the one in the background to the right.

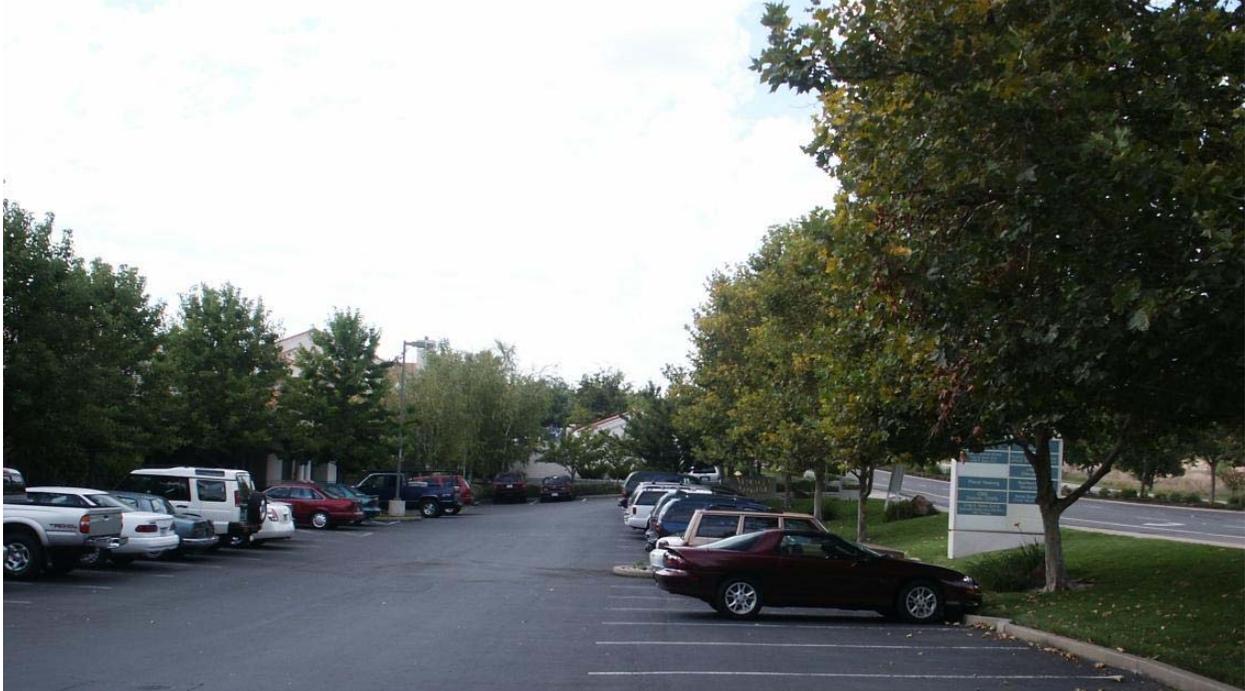
Figure 3.6-3. This professional office development (lot 7) had the highest percentage of shaded parking spaces and the lowest ratio of parking spaces to trees (2.25) of the surveyed lots.

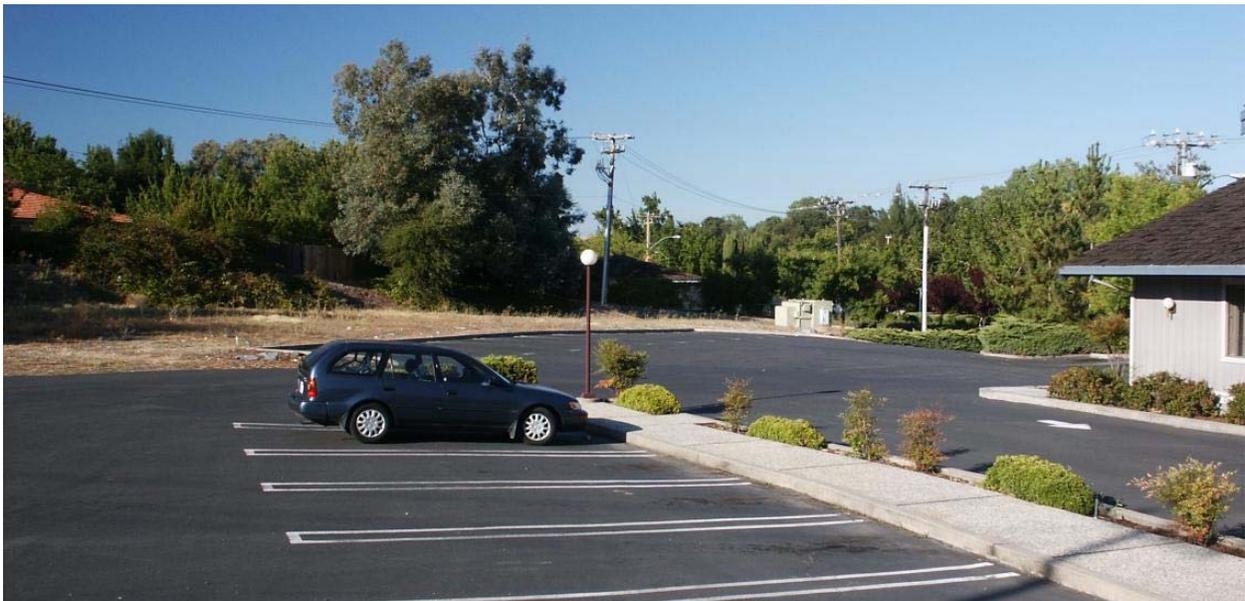
Figure 3.6-4. In lot 2, the smallest and oldest lot surveyed, few trees were planted in areas where they could shade parking spaces.

potential size, although at location 9, poor maintenance and site conditions may also be stunting tree growth. The low level of shading in lot 2 was due to the fact that most trees were in the planter between the street and lot, and few trees were properly positioned within the lot to shade parking spaces.

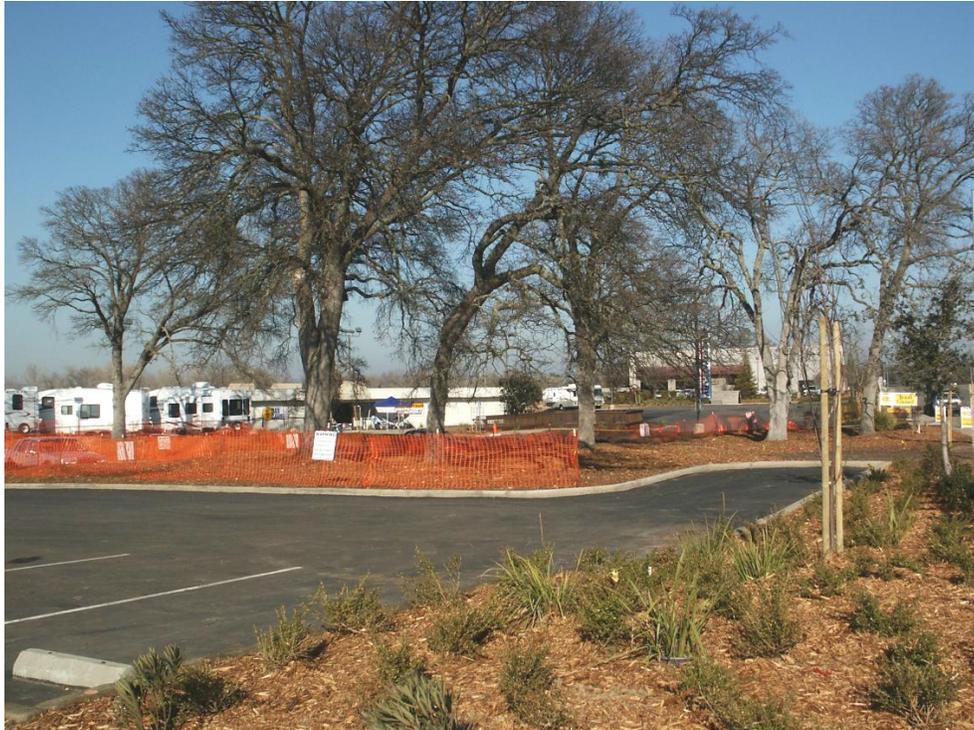
Figure 3.6-10. Conserved mature blue oaks incorporated as a group into a new parking lot, in keeping with the Design Review Resolution adopted in 2000.

Protecting roots only within the dripline is usually insufficient to allow a retained tree to attain a normal lifespan. Revising standards to set a target for protecting at least half of the rootzone and a specific zone around the trunk could improve the long-term survival prospects for retained oaks (see Appendix 7.4). Incorporating oaks as a groups into parking lots can also provide for more root zone protection (Figure 3.6-10). In addition, it is necessary to closely monitor compliance with oak protection measures during development and encourage better stewardship of retained oaks. Because mature trees have such a major effect on shading, local microclimate, and aesthetics, efforts to ensure better protection of retained oaks will provide immediate benefits.
