*Site Investigation Report of Findings*

**SIERRAPINE ROCKLIN FACILITY**

WKA No. 10467.05

October 21, 2016

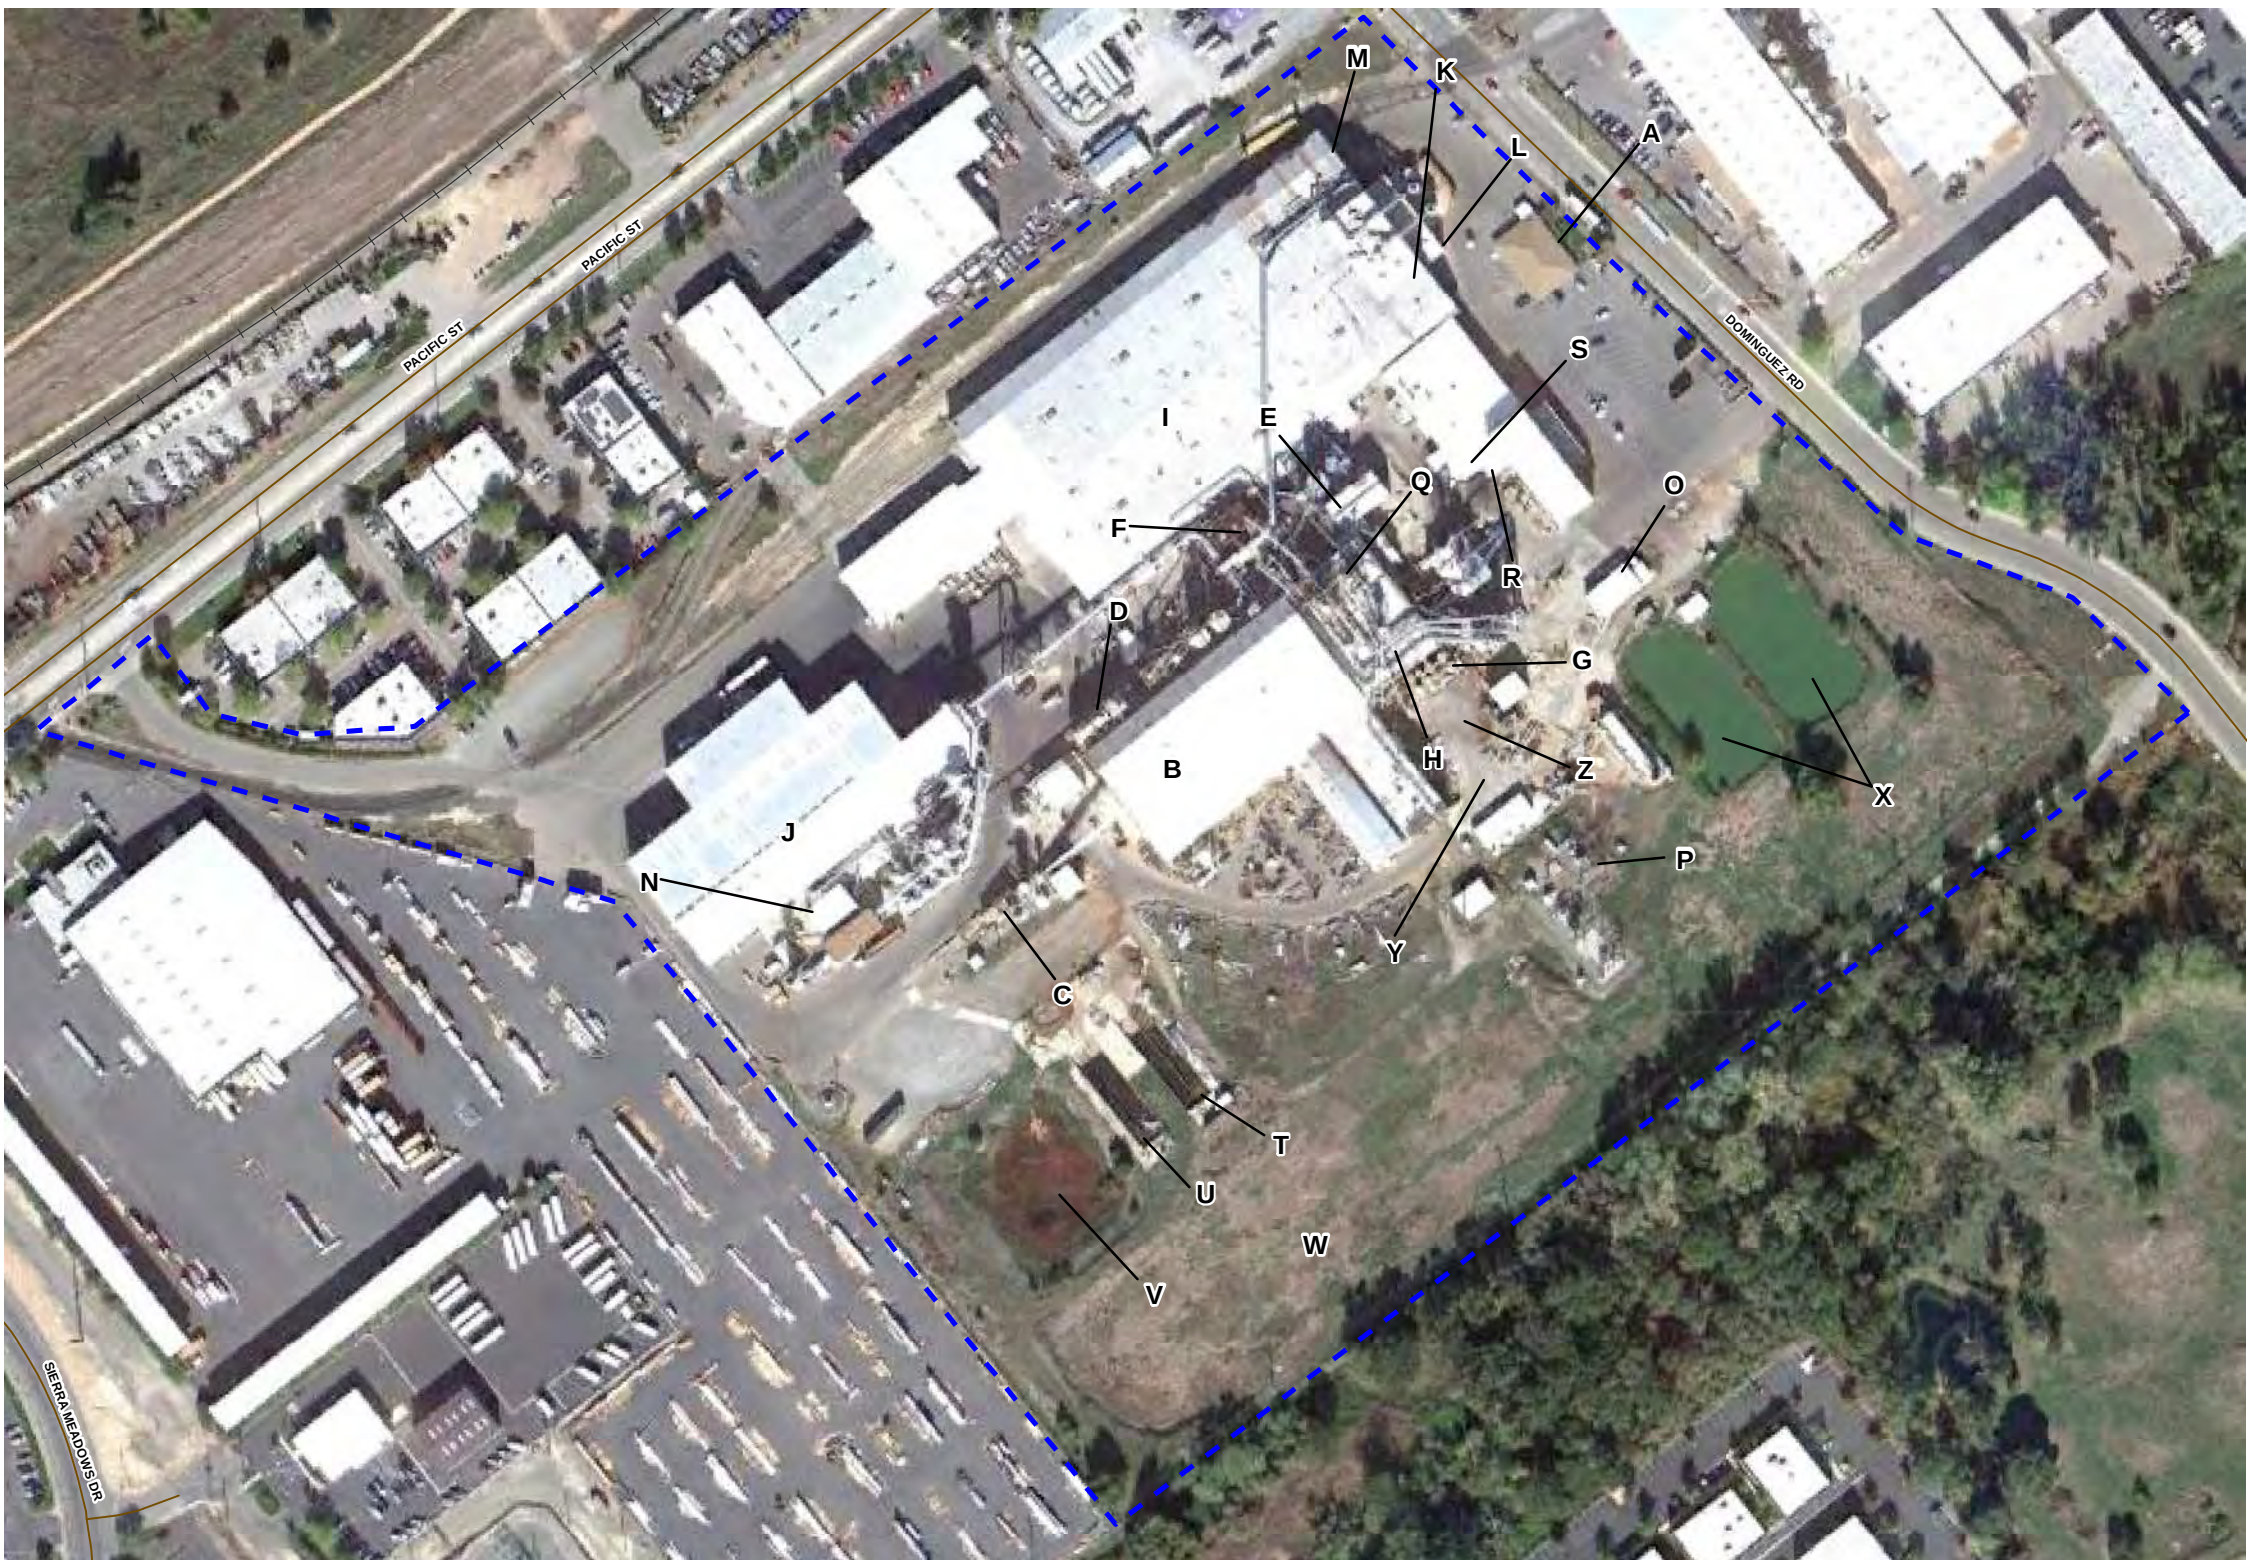
- SITE FEATURE**
- A Office Building
  - B Raw Materials Storage and Processing Building
  - C End Dump Lift
  - D Belly Dump Platform
  - E Dust-Fired Boiler
  - F Natural Gass Boiler
  - G Resin Storage Tanks
  - H Resin Mixing Area
  - I Thick Board Press Building
  - J Thin Board Press Building
  - K Thick Board Press Pit
  - L Hydraulic Control Room
  - M Oil / Water Seperator
  - N Hot Oil Storage Room
  - O Oil Shed / Ash Storage Shed
  - P Elictrical Sub Station
  - Q Main Transformer Room
  - R Auxiliary Transformer
  - S Equipment Repair / Machine Shop
  - T POTW Basin
  - U WDR Basin
  - V Clay Lined Pond
  - W WDR Spray Field
  - X Firewater Storage Ponds
  - Y AST
  - Z USTs

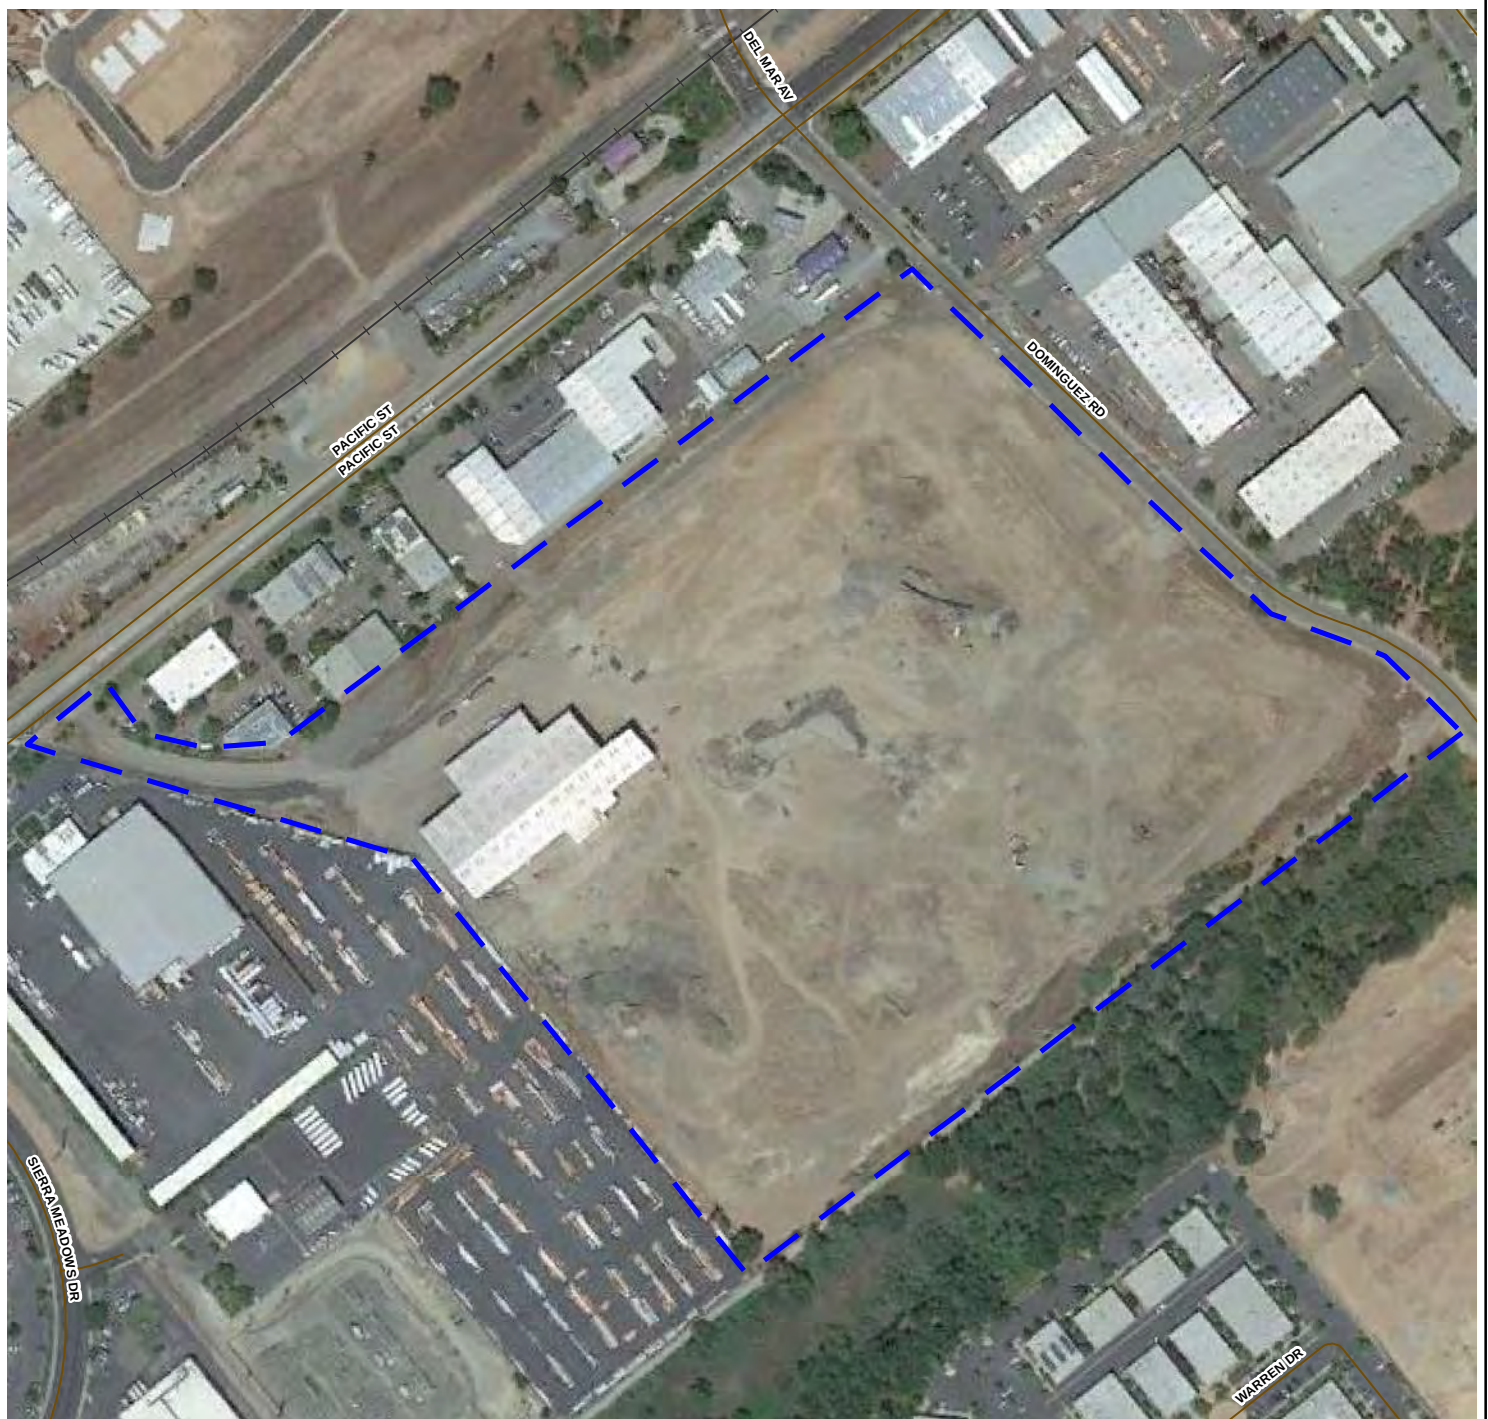
Adapted from a Google Earth aerial photograph,  
dated July 10, 2016.  
Projection: NAD 83, California State Plane, Zone II  
Groundwater Contour information collected 11/3/15.

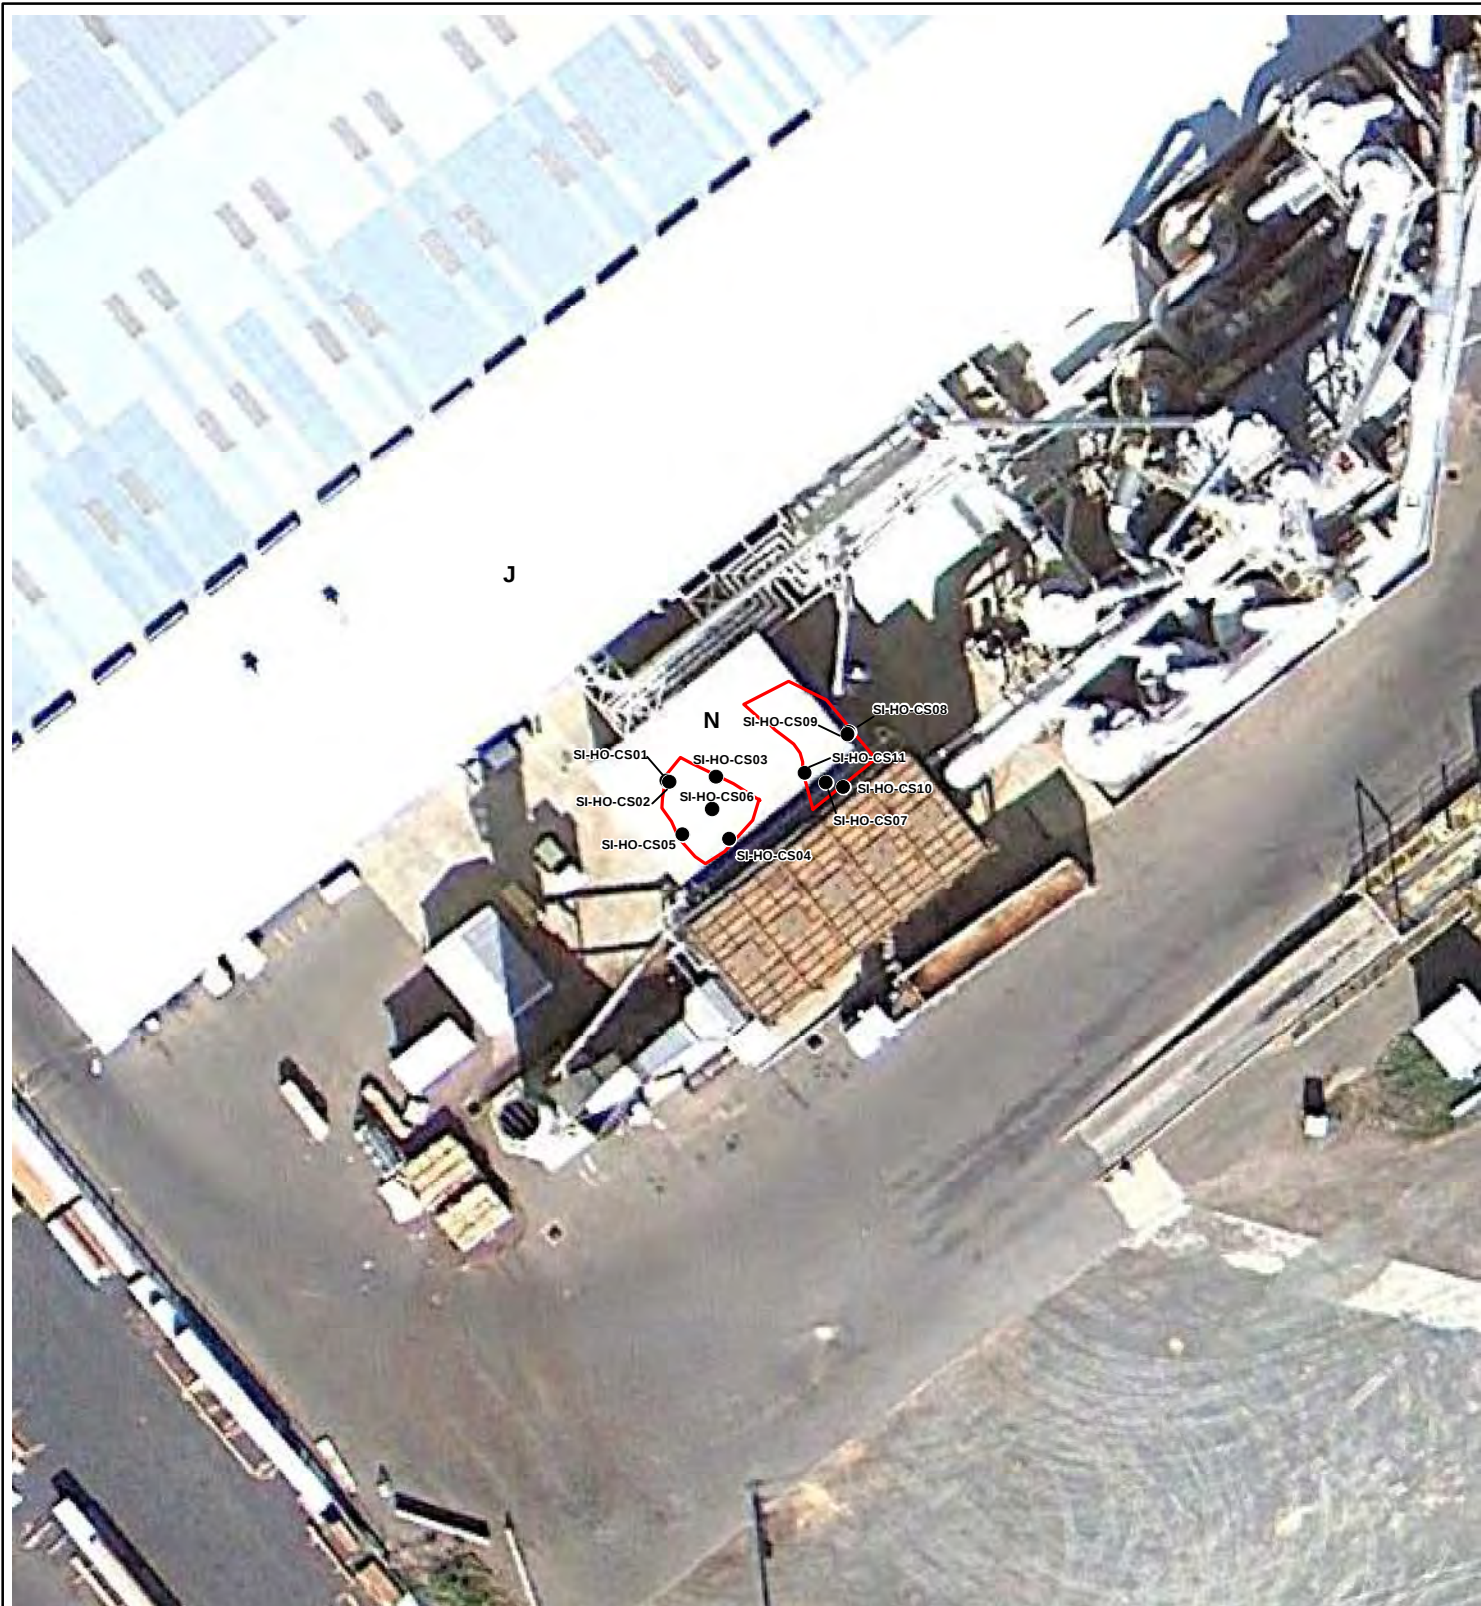
On December 29, 2015, WKA collected soil samples from three locations beneath the concrete foundation of the former oil shed/ ash storage shed (Figure 12). Two samples were collected from each location using hand-sampling methodologies. One sample was collected from soil representing the interval directly underneath the concrete foundation (SI-OS-S01a through SI-OS-S03a). The second sample was collected in the interval from two to two and a half feet below the concrete liner (SI-OS-S01b through SI-OS-S03b). WKA observed soil directly beneath the concrete liner to be a brown silty sand including various amounts of angular gravel intermixed with construction/ demolition debris, which included broken asphalt, concrete, and metal. In the deeper interval, the soil was observed to be gray fine to coarse sand with gravel consistent with highly weathered granodiorite. The six soil samples collected beneath the former hot oil room were analyzed for TPHd, TPHho, TPHg, CAM 17, chromium VI, TPHmo, VOCs, and PAHs.

On January 4, 2016, WKA collected soil samples from eight locations within the limits of the two firewater storage ponds (Figure 12). Four sample locations were selected within each basin. WKA observed that each pond was constructed of earthen berms and lined with a clay liner. At each sample location one sample of the clay liner was collected (SI-FP-S01a through SI-FP-S08a) and one soil sample was collected from beneath the clay liner (SI-FP-S01b through SI-FP-S08b). The clay liner was observed to be a buff to gray plastic clay approximately four inches thick. Under the liner, the soil was observed to be brown silty sand with gravel, consistent with soil used to construct the containment berm. In each basin, a layer of dried sediment was observed at thicknesses from three to 10 inches thick and was composed of brown low-density organic material.

2.1 and 1.9 mg/kg. Both TPHmo detections were found in samples collected from the clay liner. TPHd, TPHho, TPHg, and VOCs were not detected in soil samples collected from the firewater storage ponds. CAM 17 metals were not detected at concentrations exceeding the CHHSLs for occupancy under a residential scenario. Based on these results, no further study was necessary.
