**RE: Arborist Report for Potential Development Impacts for the Wolff Project near the intersection of Pacific and Midas Avenues in Rocklin, California.**

# **ARBORIST REPORT**

## **Wolff Project**

Arborist Report  
for  
Wolff Project  
Intersection of Pacific & Midas Avenues  
Rocklin, CA

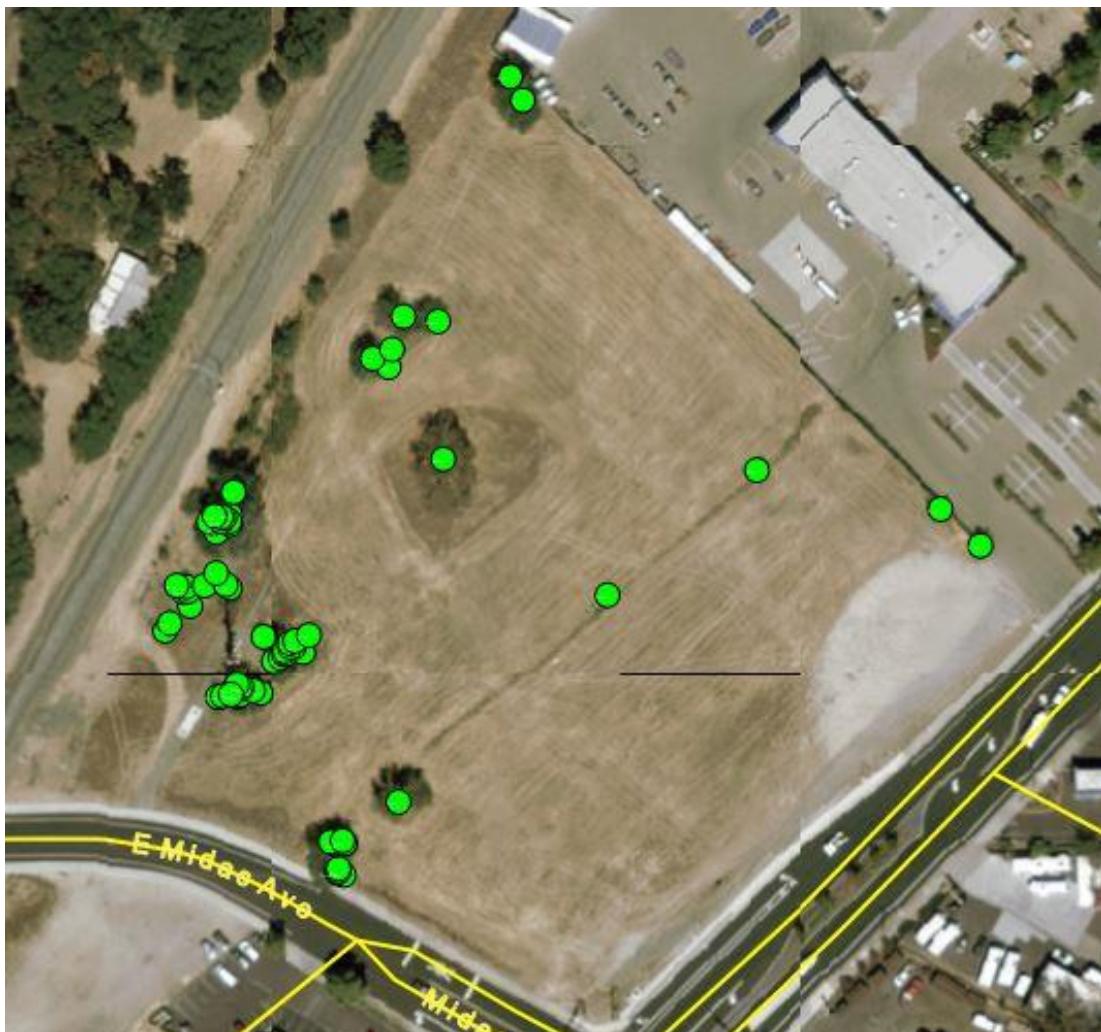
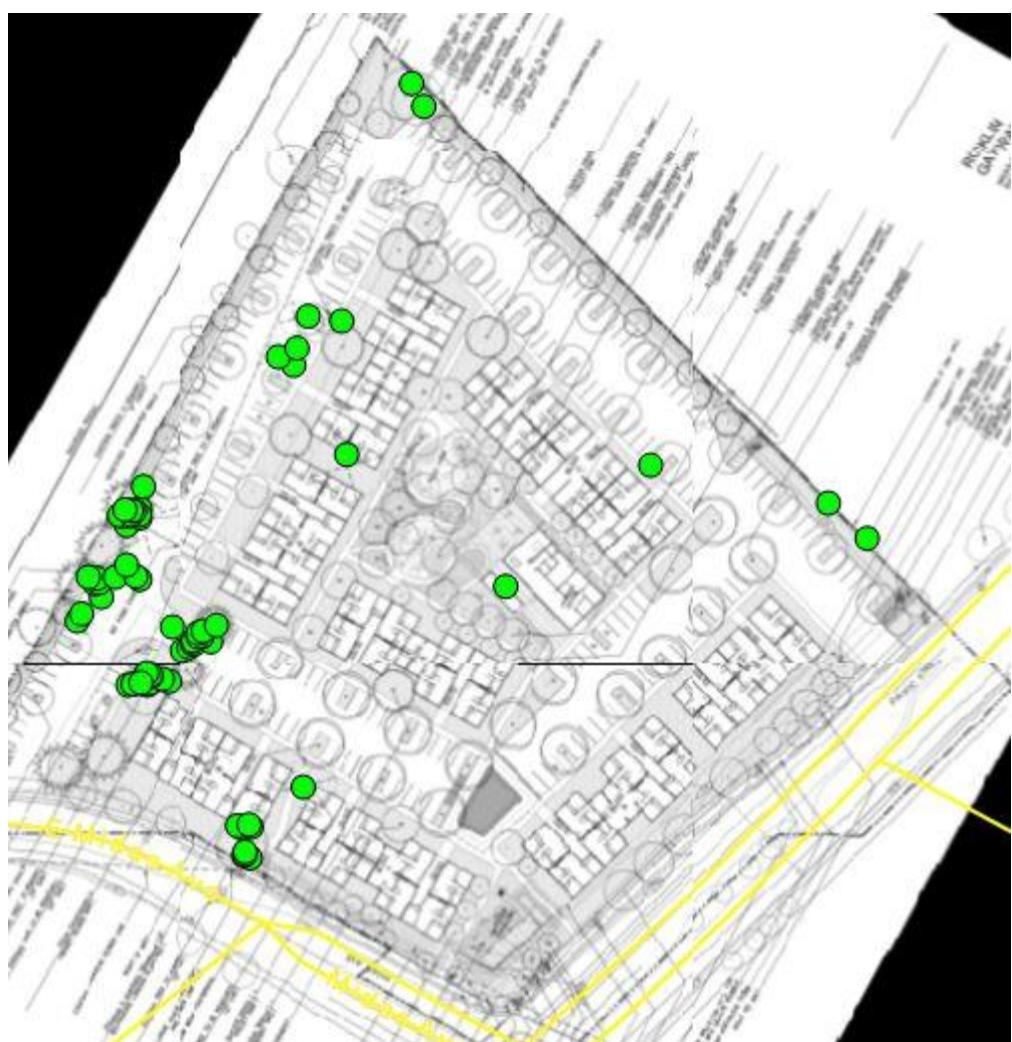
## Appendix C. Site Plan Comparison

The following two images relate the general locations of all 69 tree inspections to the site plan

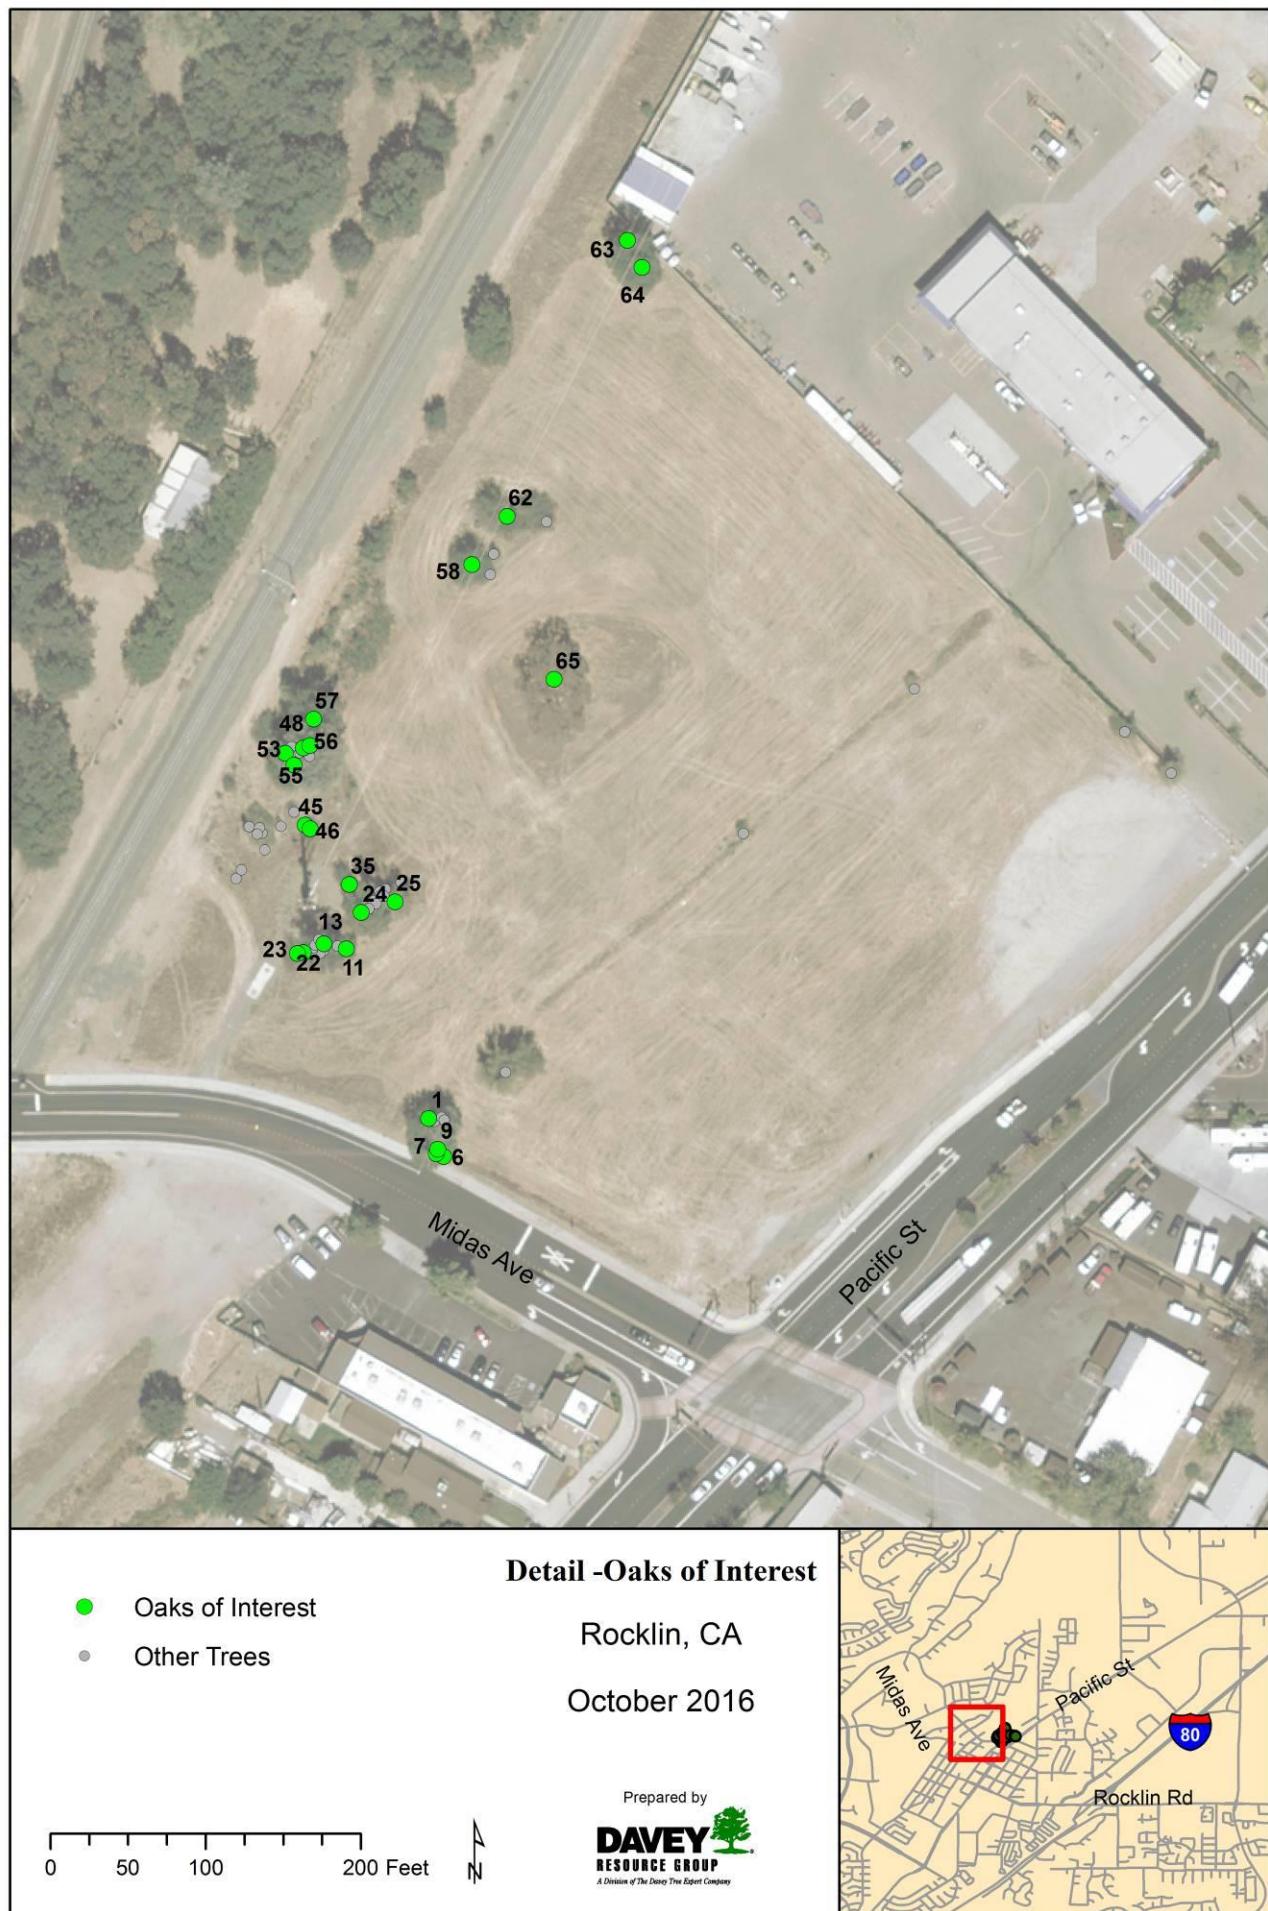
## **Appendix D. Inventory Map**

The following inventory map detail shows the location and site number of the 23 oak trees of interest.
